Landslide Disaster and Hill Slope Instability Mitigation along National Highway Corridor for Safe and Sustainable Infrastructure Development in Indian Difficult Terrain

Technical Conference – 5th Inception Day
18th July 2019

Dr. D.P. Kanungo

CSIR-Central Building Research Institute, Roorkee, INDIA

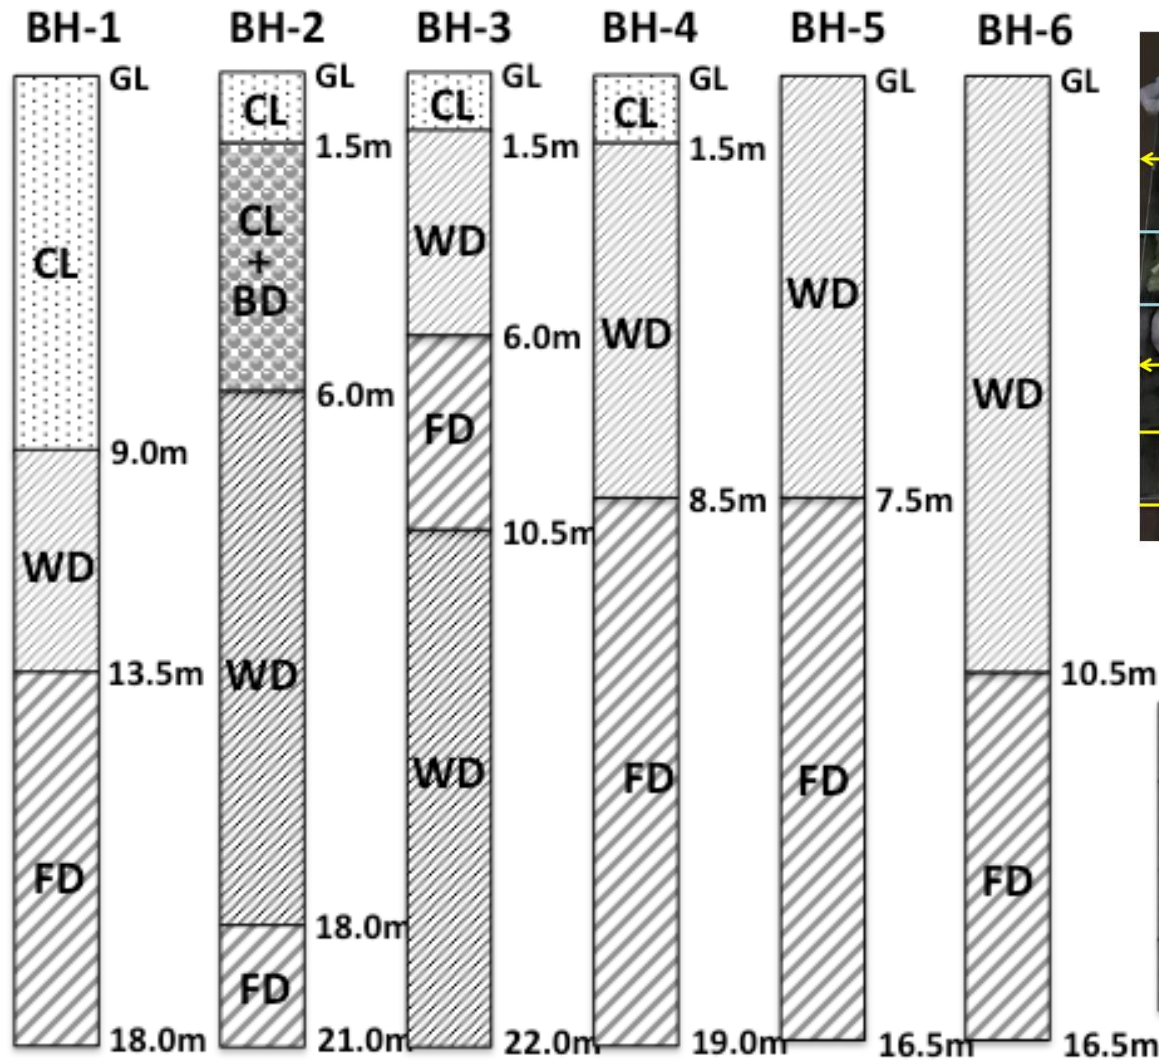
(a)

Drilling and Borehole Logging

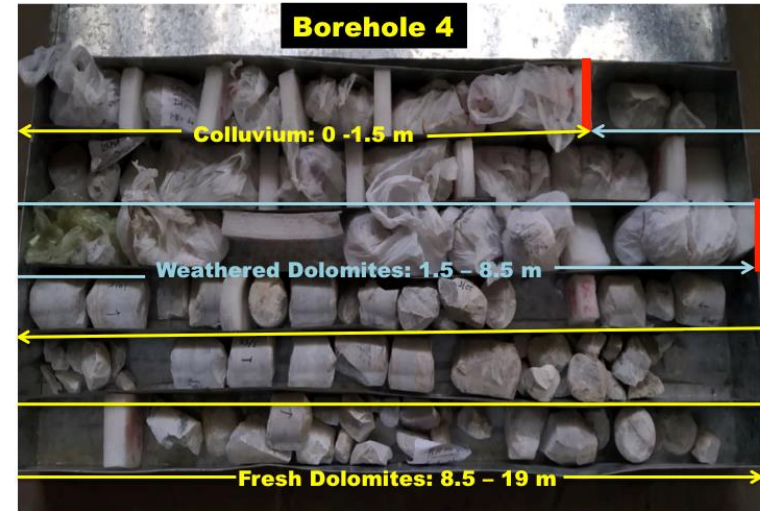
(b)

- CL Colluvium (CL)
- CL + BD Colluvium with Boulder (CL+BD)
- WD Weathered Dolomites (WD)
- FD Fresh Dolomites (FD)

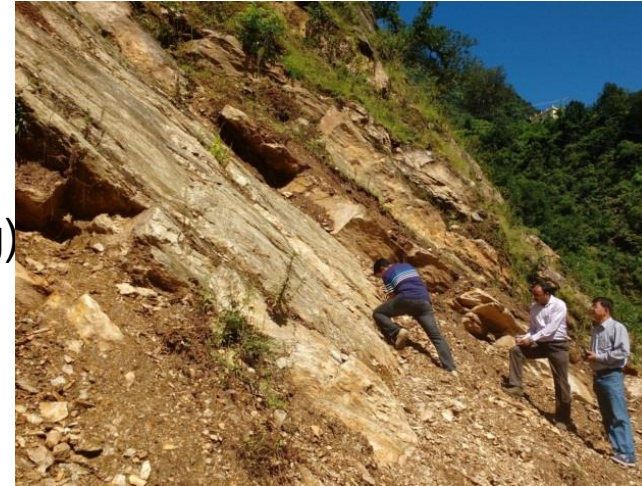
Rock Mass Characterization

- ✓ Joint attributes (dip, dip direction)
- ✓ Joint shear strength properties (JRC, JCS)
- ✓ Joint condition details (roughness, weathering, infilling)
- ✓ Rock mass characterization (GSI, RMR)

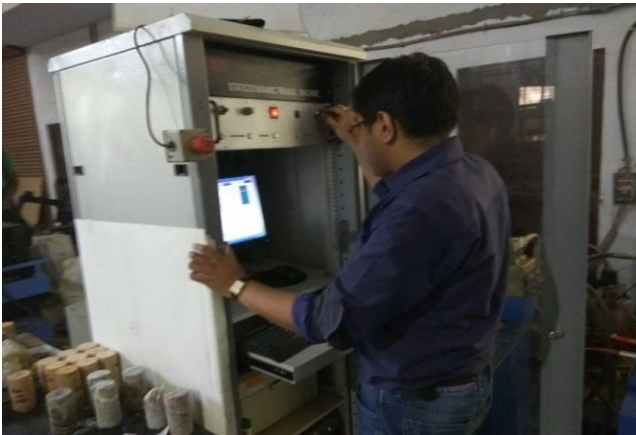
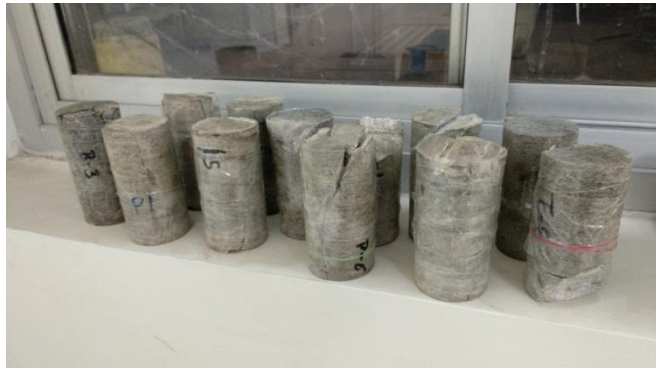
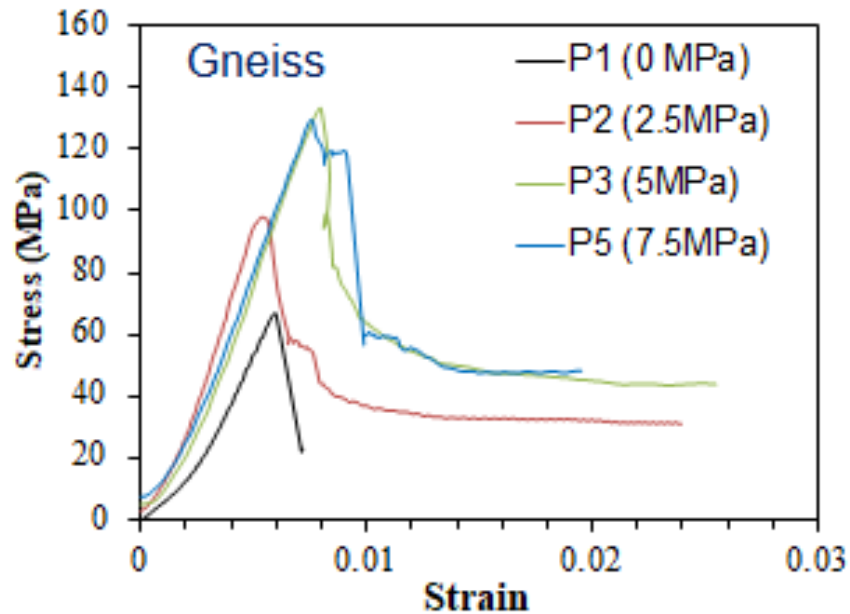
Laboratory testing of Intact Rock

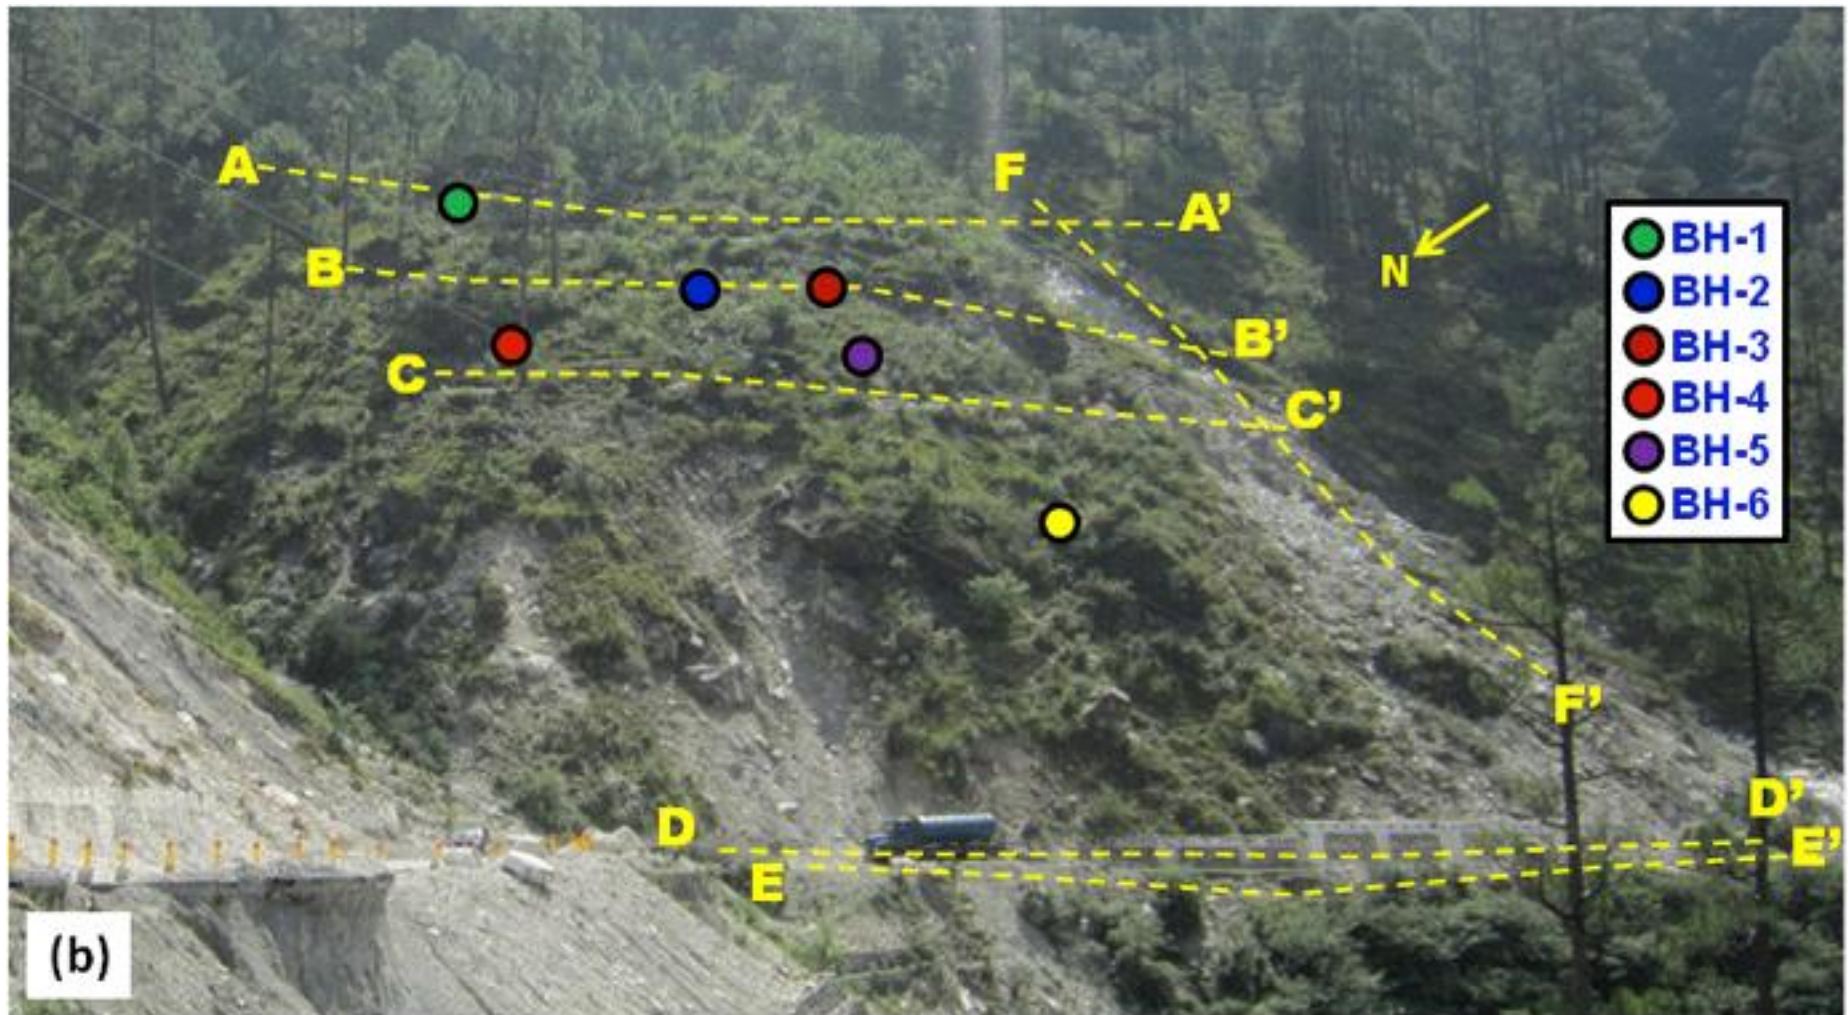
Electrical Resistivity Tomography (ERT)

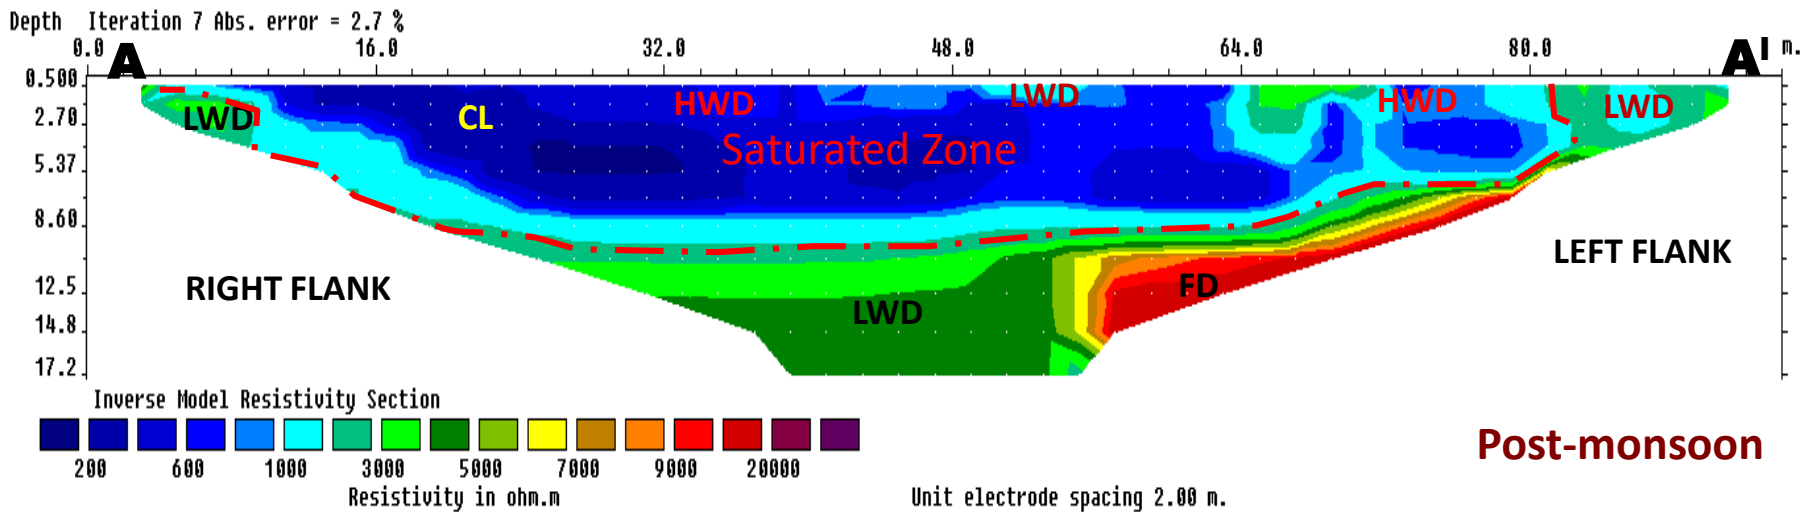
Pre- and Post-monsoon ERT of Landslide

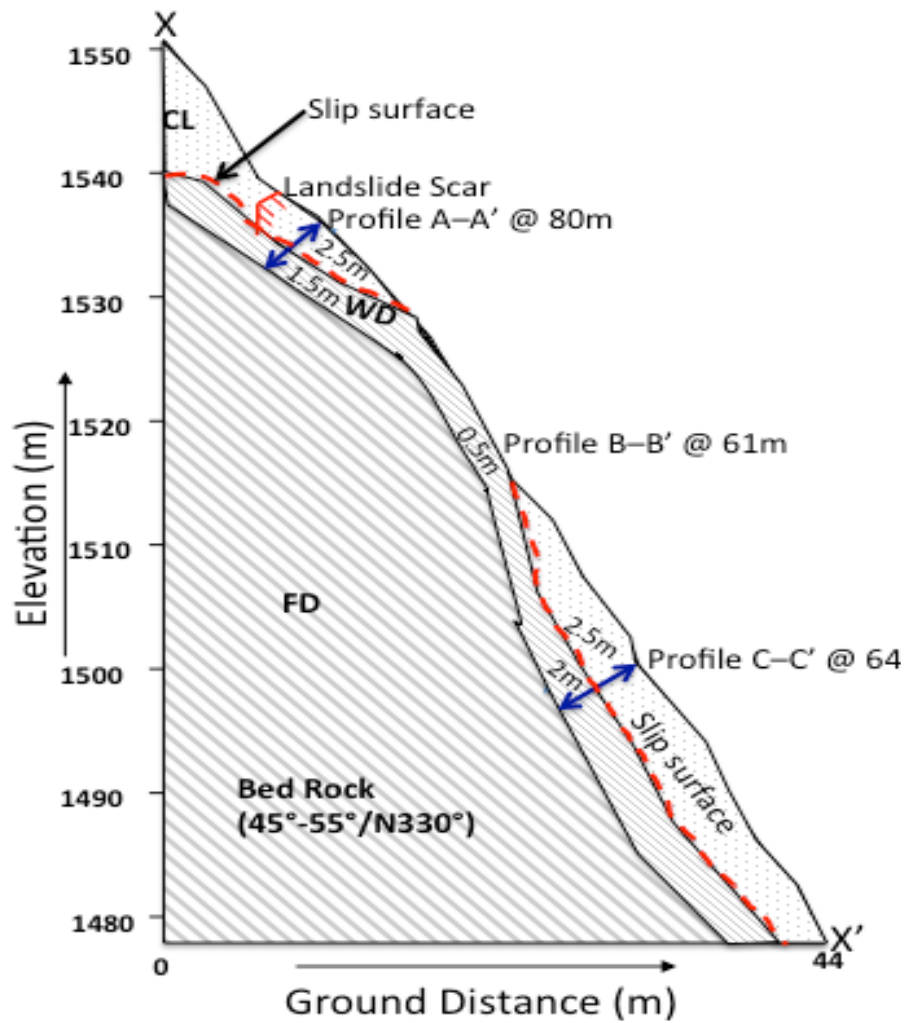
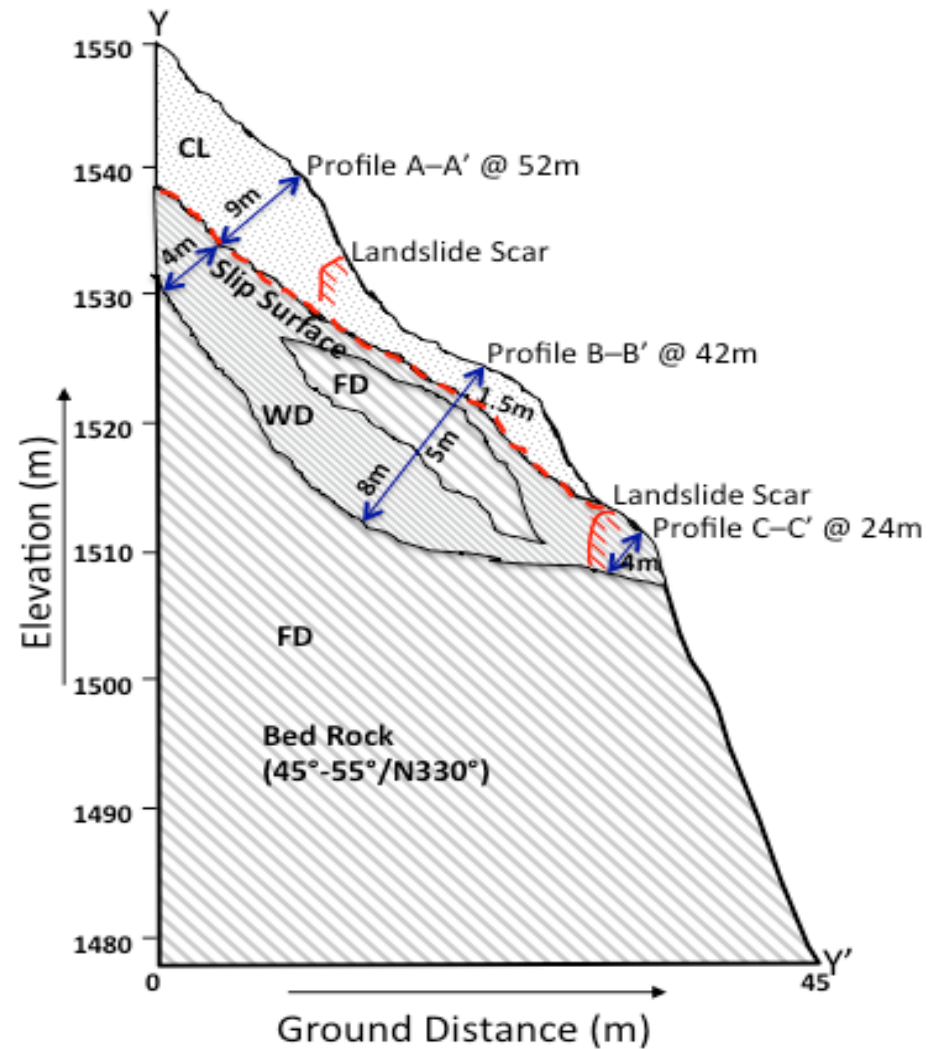
Numerical Modeling: Material Model & Properties

1 st Case	2 nd Case
Top Soil	<p>Material model: Mohr-Coulomb</p> $\tau = c + \sigma_n \tan\phi$ <p>Elastic properties (Griffiths 1998): Elastic modulus (E) = 105 kN/m² Poisson's ratio (ν) = 0.3</p>	<p>Material model: Mohr-Coulomb</p> $\tau = c + \sigma_n \tan\phi$ <p>Elastic properties (Griffiths 1998): Elastic modulus (E) = 105 kN/m² Poisson's ratio (ν) = 0.3</p>
Bottom Soil	<p>Material model- Generalized Hoek-Brown</p> $\sigma_1 = \sigma_3 + \sigma_{ci} \left((m_b * \sigma_3 / \sigma_{ci}) + s \right) a$ $m_b = m_i \exp\left(\frac{GSI - 100}{28 - 14D}\right)$ $s = \exp\left(\frac{GSI - 100}{9 - 3D}\right)$ $a = 1/2 + 1/6 + \left(e^{\frac{-GSI}{15}} - e^{\frac{-20}{3}} \right)$ <p>D=0 (Natural Slope)</p> <p>Strength and elastic properties: GSI = 15, UCS (σ_{ci}) = 3 MPa, m_i = 9, E = 0.4 GPa and ν = 0.3 (Marinos-Hoek,2000 & Cai et.al., 2003)</p>	<p>Material model: Mohr-Coulomb</p> $\tau = c + \sigma_n \tan\phi$ <p>Elastic properties (Griffiths 1998): Elastic modulus (E) = 105 kN/m² Poisson's ratio (ν) = 0.3</p>

Bed Rock	<p>Material model- Generalized Hoek-Brown</p> $\sigma_1 = \sigma_3 + \sigma_{ci} \left((m_b * \sigma_3 / \sigma_{ci}) + s \right) a$ <p>Strength and elastic properties: GSI = 60, UCS (σ_{ci}) = 90 MPa, m_i = 9, E = 10.7 GPa and ν = 0.25 (Marinos-Hoek,2000 & Cai et.al., 2003)</p>	<p>Material model- Generalized Hoek-Brown</p> $\sigma_1 = \sigma_3 + \sigma_{ci} \left((m_b * \sigma_3 / \sigma_{ci}) + s \right) a$

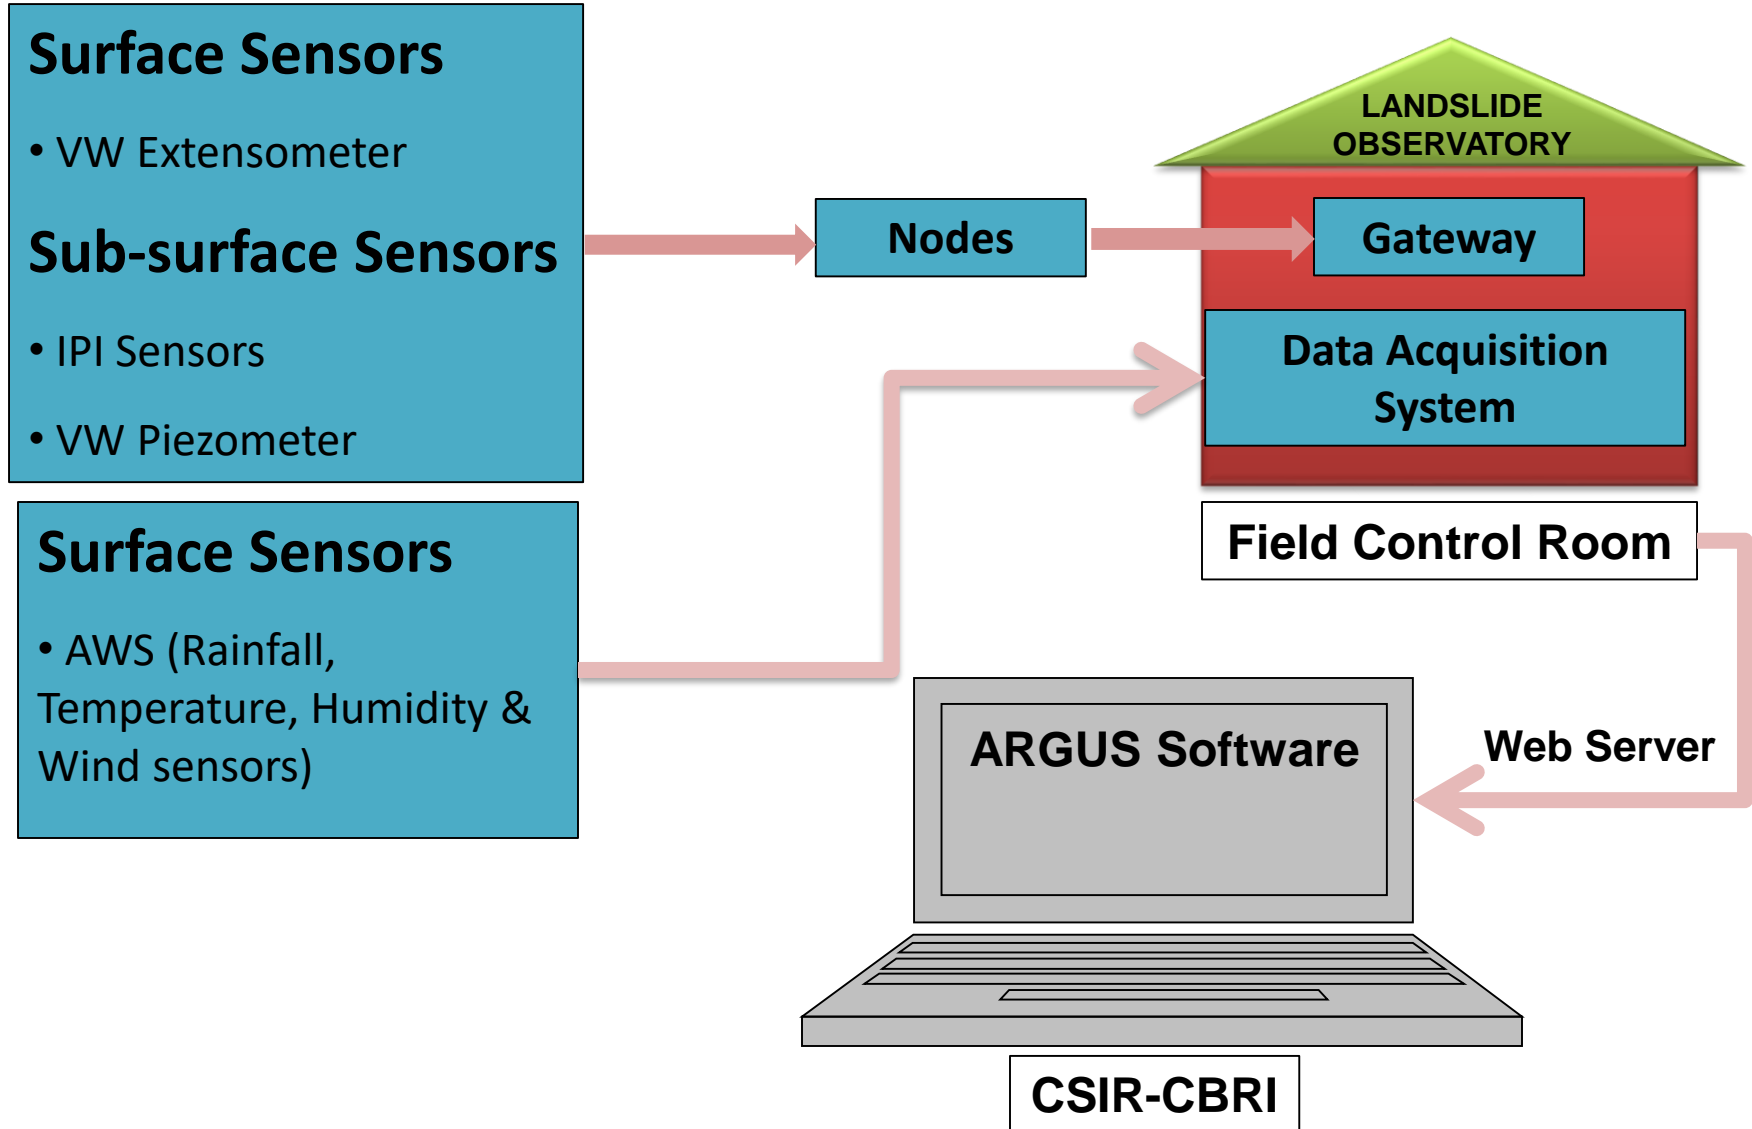
Wireless Landslide Instrumentation & Real Time Monitoring System

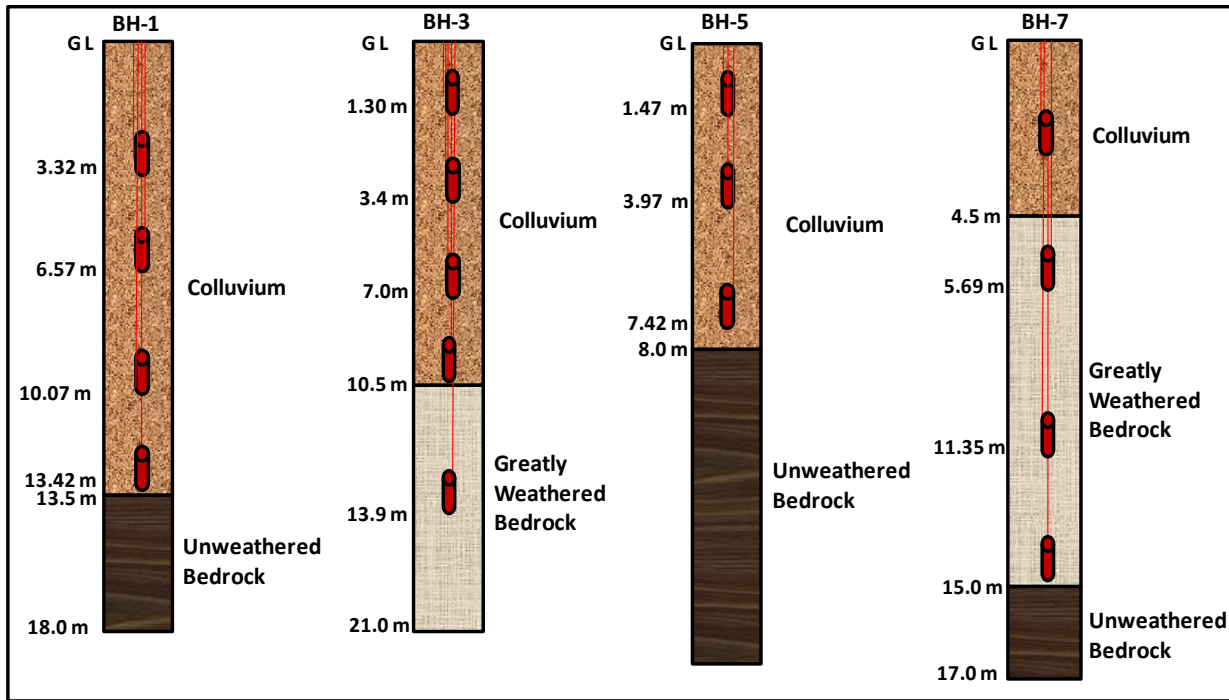
IPI Sensors

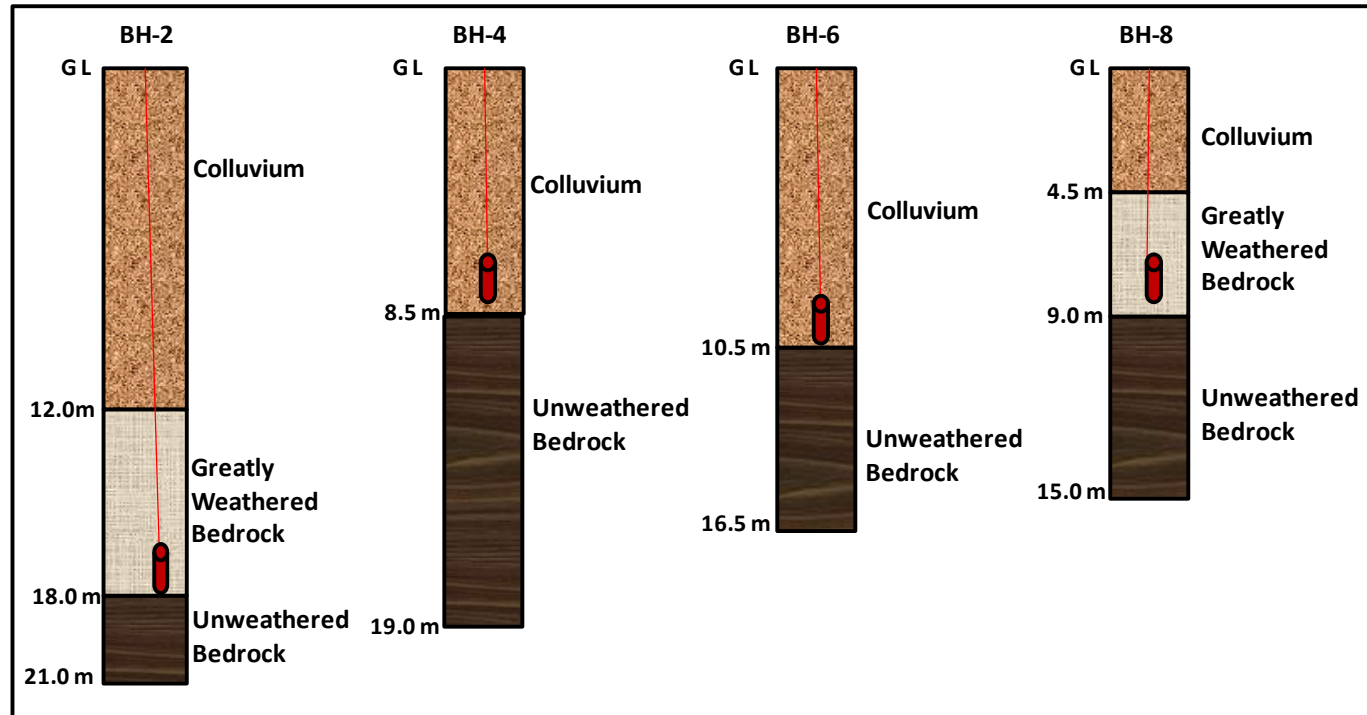
VWP Sensors

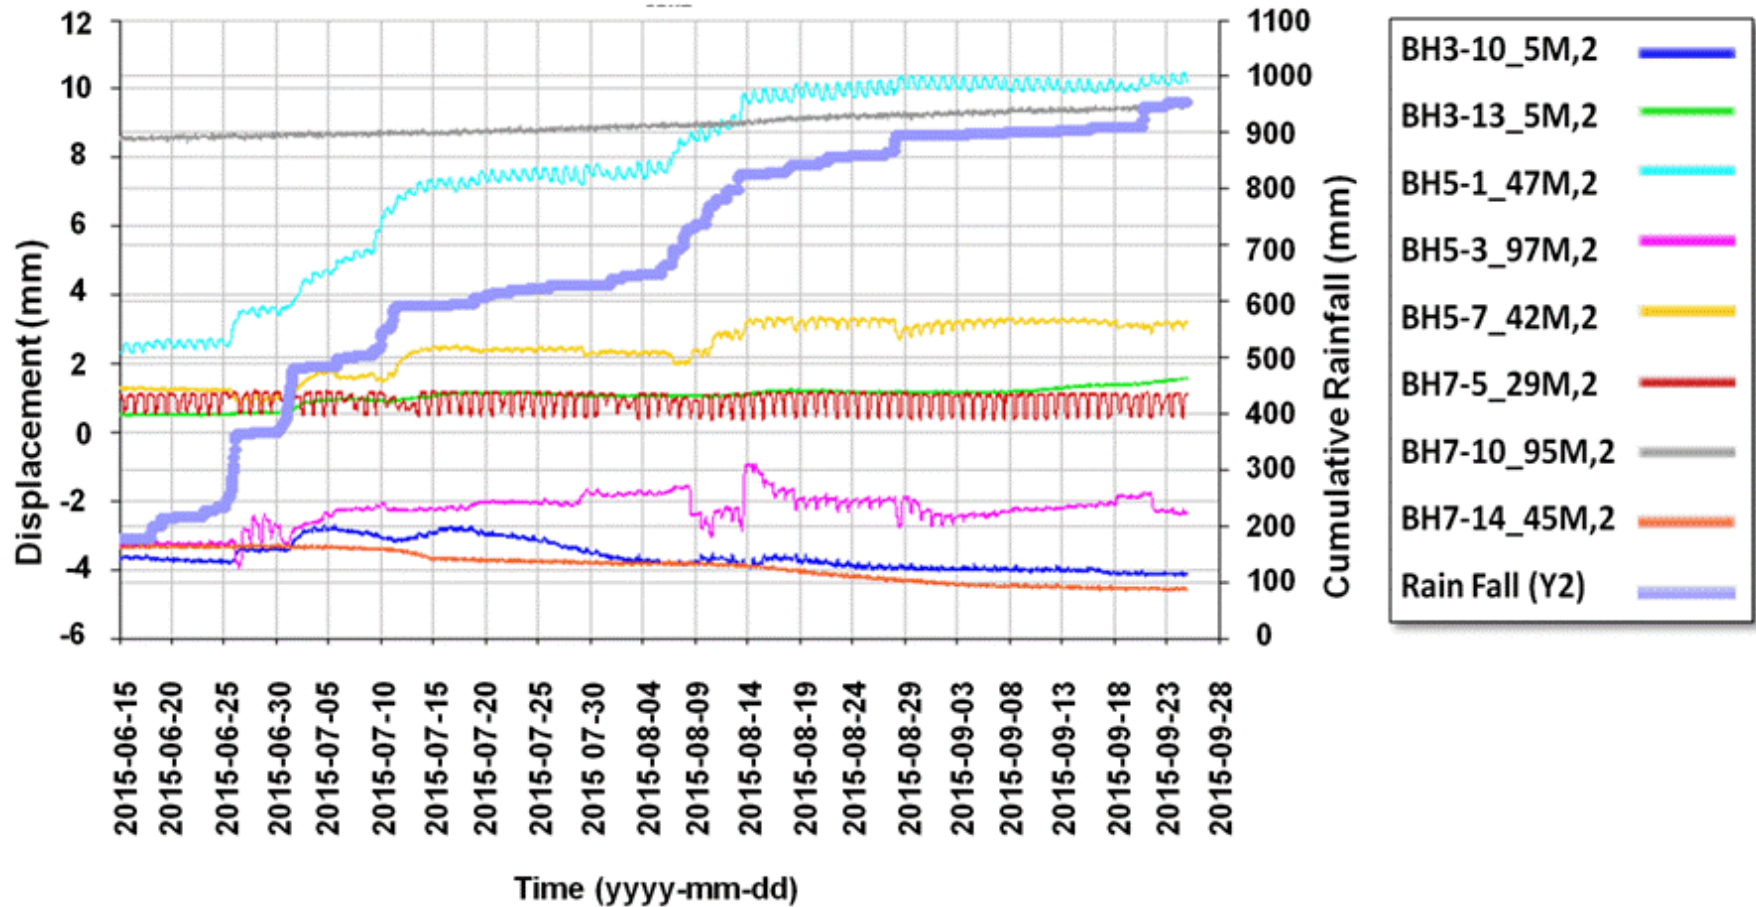
Cumulative displacement (mm) as observed from IPI sensors (B-axis) in boreholes during monsoon period

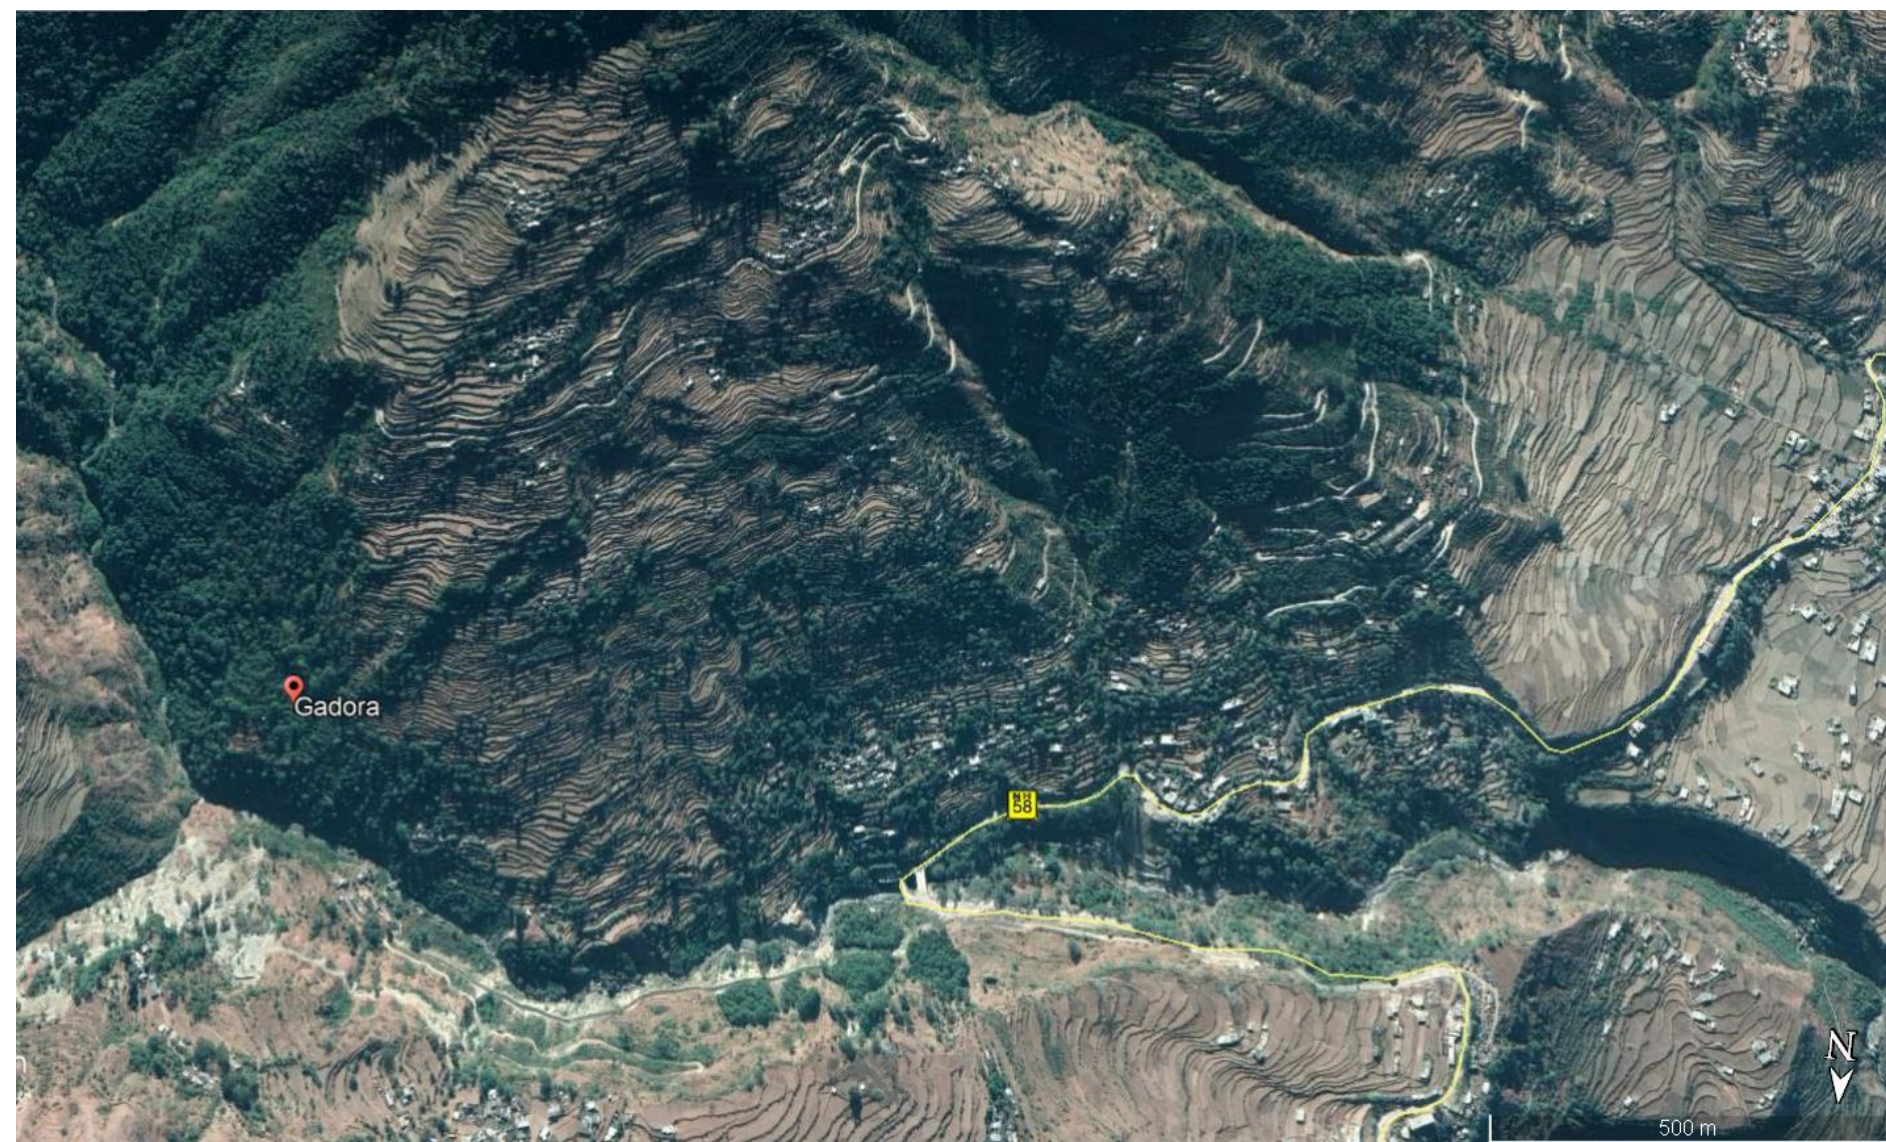
Gadora Village Subsidence Zone along NH-07 under Chardham Pariyojna

- Old landslide accumulated debris
- Multiple transverse and longitudinal cracks witnessed
- Colluvial soil deposit/debris overburden above in-situ rock
- Terrace cultivation infers localized aquifer/water charged area.
- Water seepage on slope
- Loaded with building infrastructure
- Subsidence zone (creep movement)

- **Planning and Design of remedial measures**
 - **Multi-level measures – starting from valley side through road level up to crown of the landslide**
 - **Retaining structures – Road & Valley side**
 - ✓ **RCC retaining wall/Piling/Gabion wall**
 - **Terracing on slope with soil nailing/retaining structures**
 - **Drainage measures –**
 - **Catch water drain/collection drain**
 - **Drainage well/Inclined radial sub-surface drain (pressure relief)**

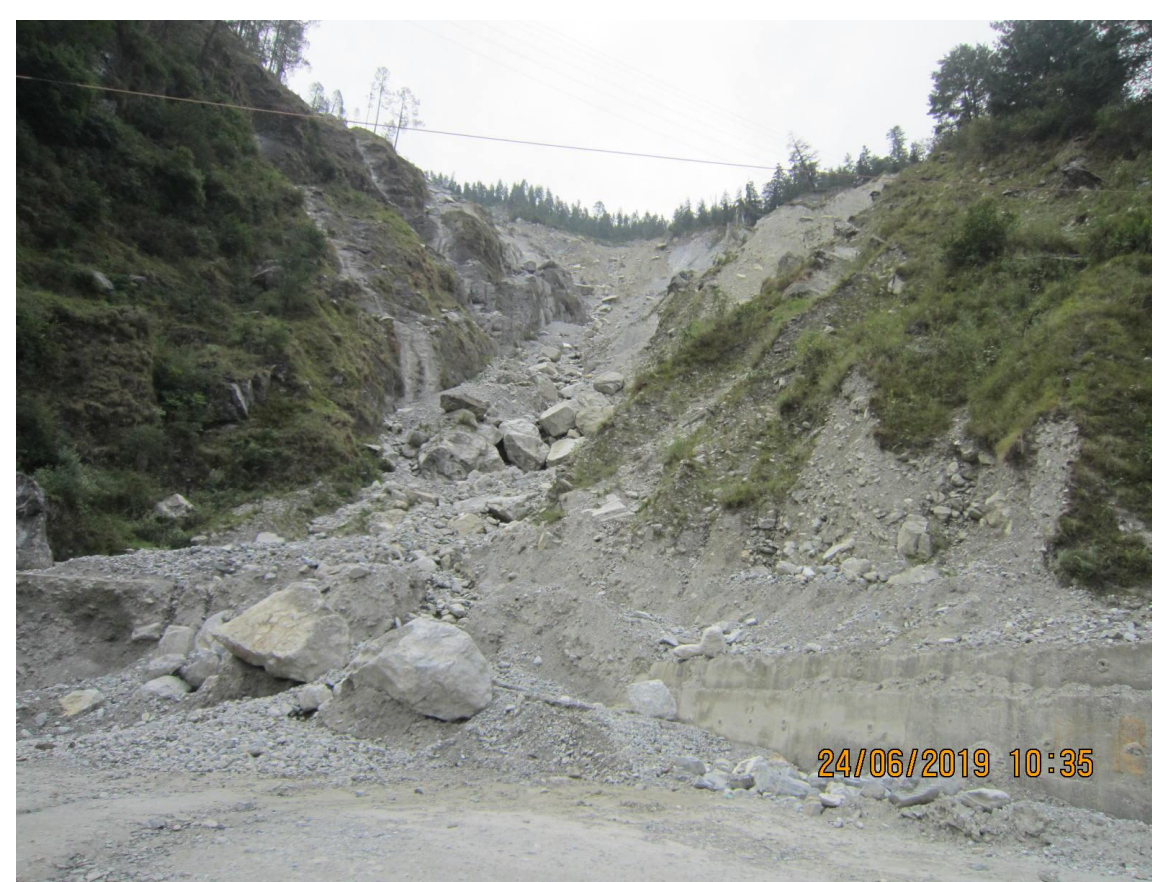
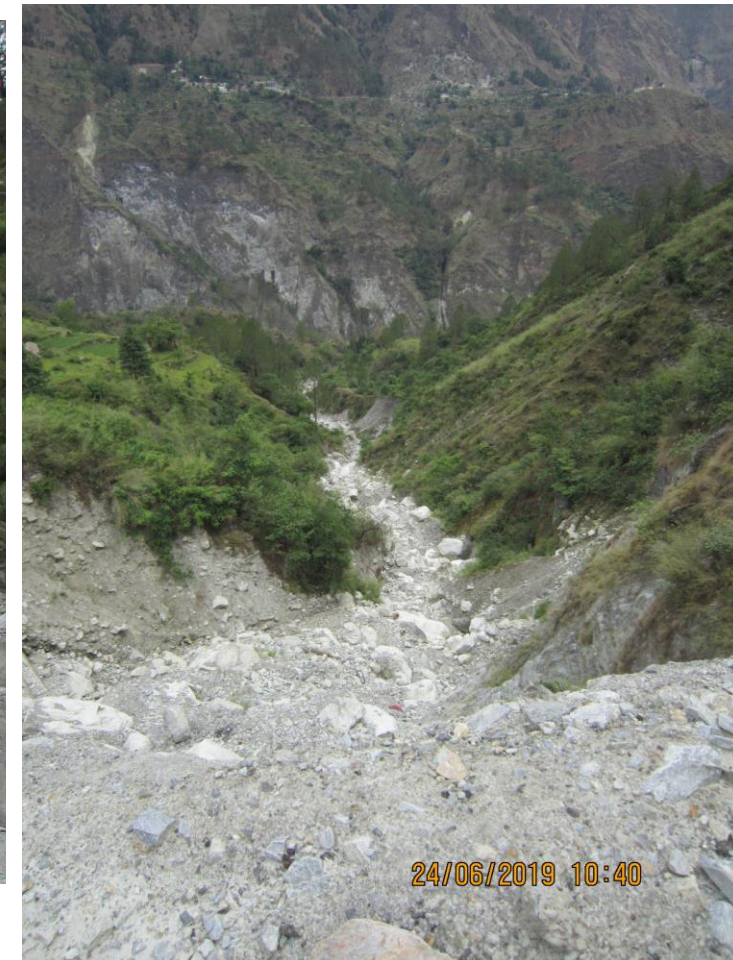
Pagal Nala (Tangni) Landslide along NH-07 under Chardham Pariyojna

- Uncontrollable Landslide
- Bridge is the only option to avoid the landslide

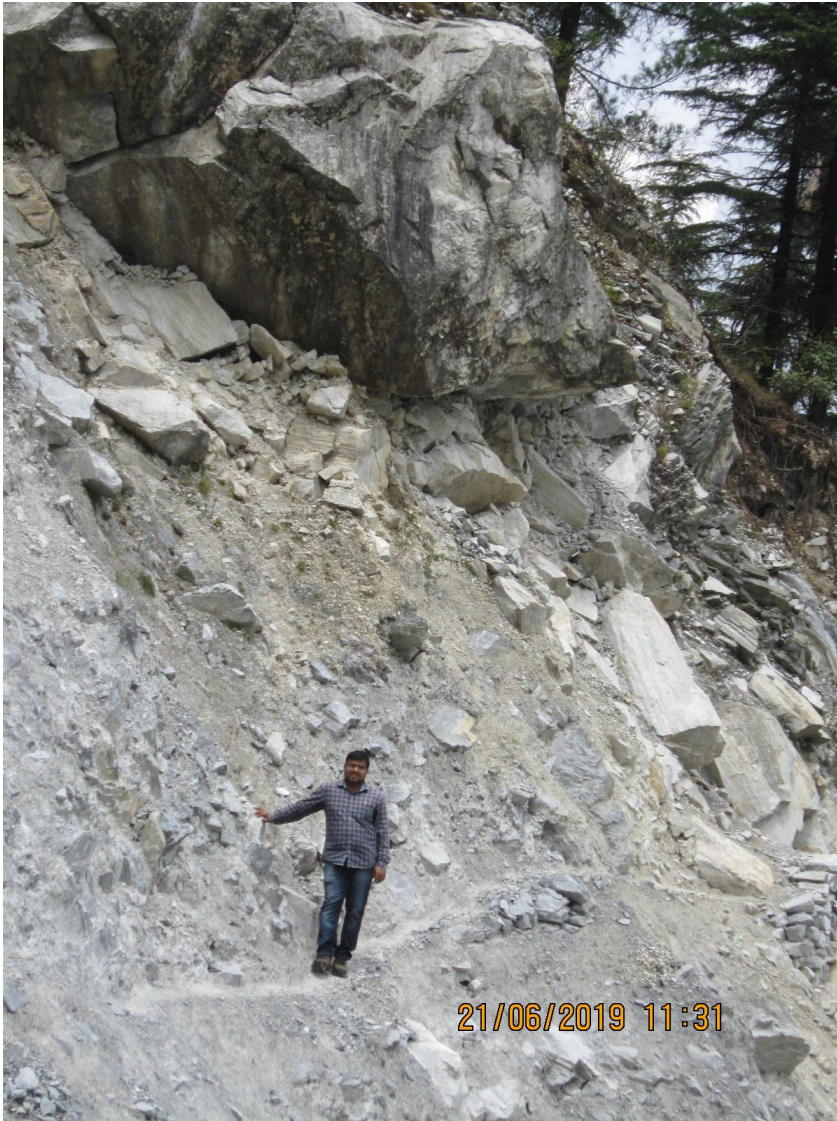
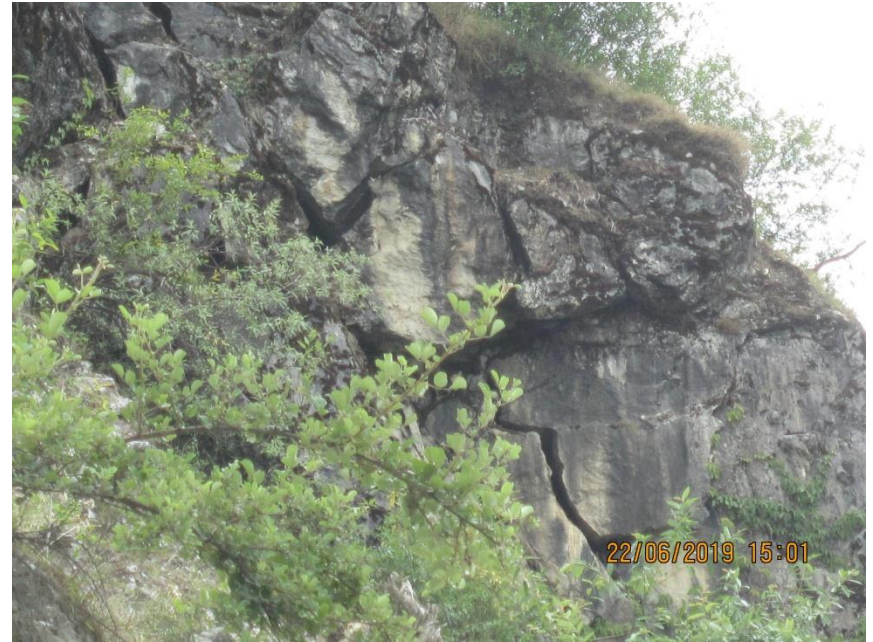
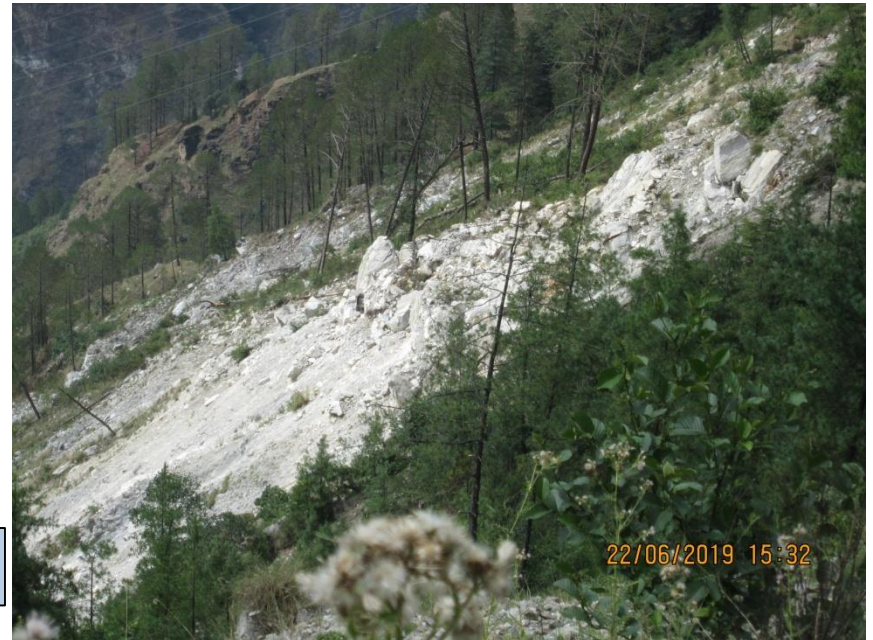
Pagal Nala (Tangni) Landslide

Loose Rock Boulders at Landslide Source Area
