# Package-4

***Bore Log & Core Samples  
Photographs  
B-18***

| Project Name | | Consultancy Services for additional Topographical, Geotechnical Survey for widening and upgradation of NH-54 from km 8.00 to km 380.00 in the State of Mizoram. | | | | | | | | | | BPC Consultant INDIA (P) Ltd. | | | | | | | | | | | | | | | | | | |
| BORE / CORE LOG DATA SHEET | | | | | | | | | | | | | | | | | | | | | | | | | | | | | | |

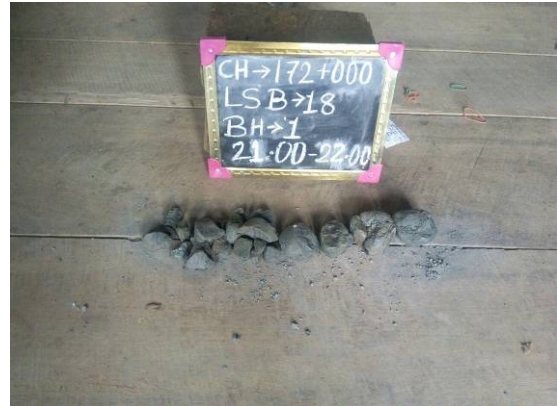
PICTURE 01: BH- 1 (Depth-20.00 to 21.00m)

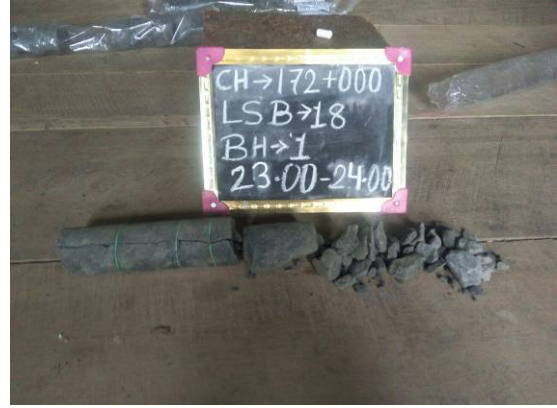
PICTURE 03: BH-1 (Depth-22.00 to 23.00m)

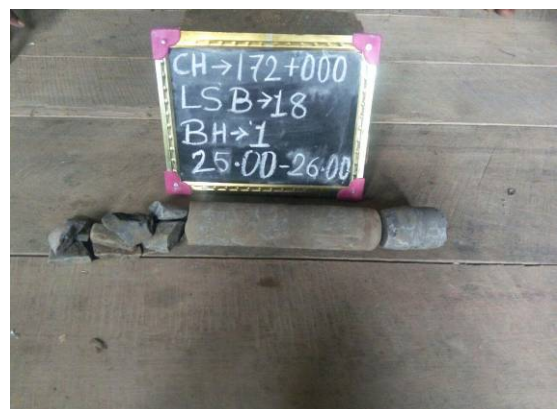
PICTURE 05: BH-1 (Depth-24.00 to 25.00m)

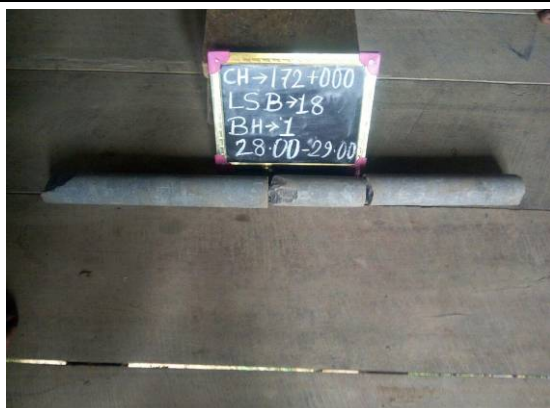
PICTURE 08: BH-1 (Depth-27.00 to 28.00m)

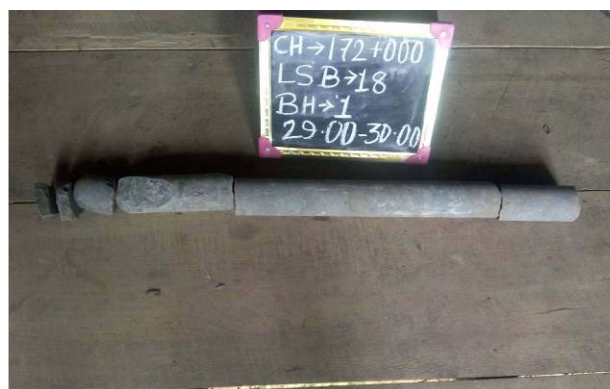
PICTURE 09: BH-1 (Depth-28.00 to 29.00m)

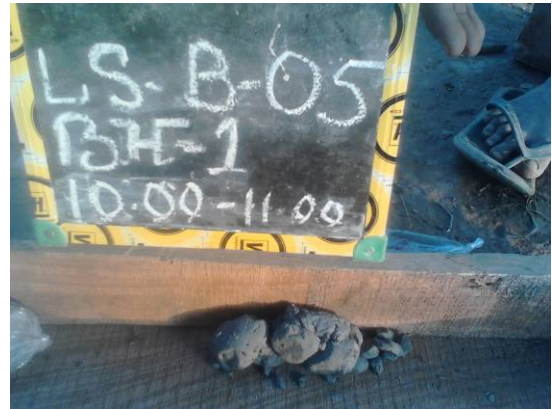
PICTURE 15: BH-11 (Depth-9.00 to 10.00m)

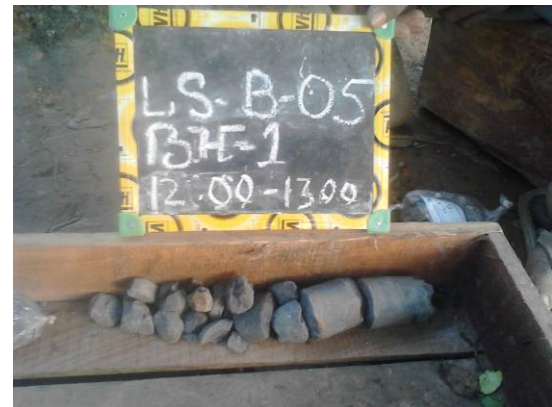
PICTURE 13: BH-1 (Depth-11.00 to 12.00m)

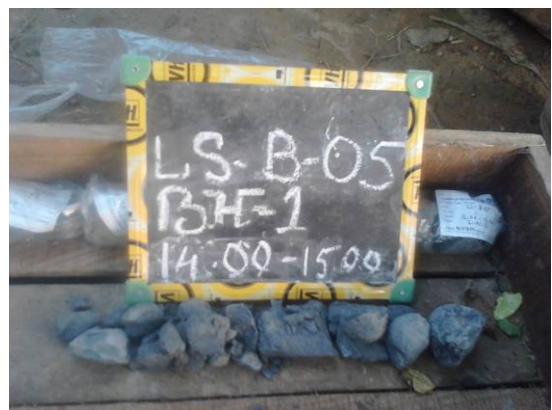
PICTURE 15: BH- 1 (Depth-13.00 to 14.00m)

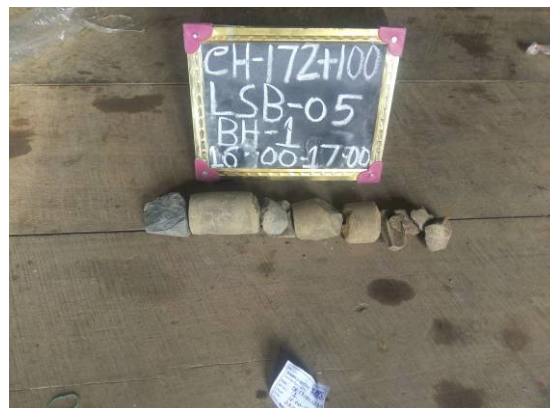
PICTURE 17: BH-1 (Depth-15.00 to 16.00m)

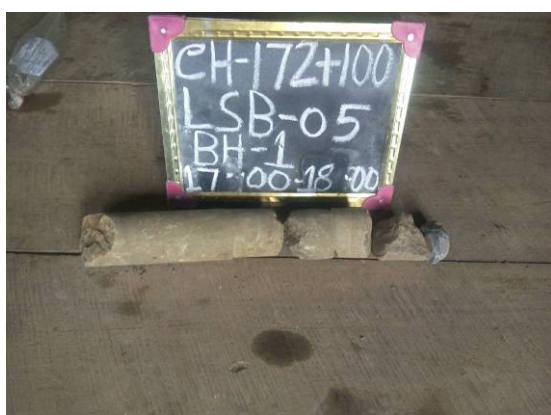
PICTURE 18: BH-1 (Depth-16.00 to 17.00m)

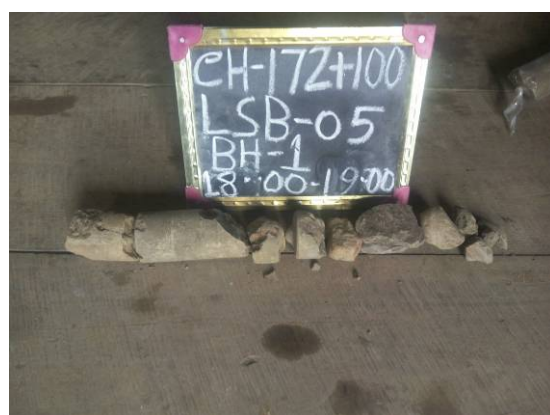
PICTURE 19: BH-1 (Depth-17.00 to 18.00m)

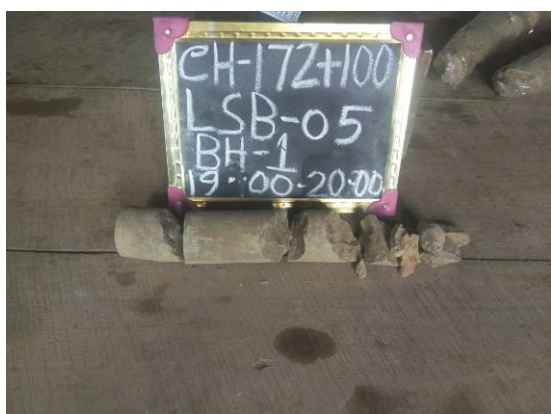
PICTURE 20: BH-1 (Depth-18.00 to 19.00m)

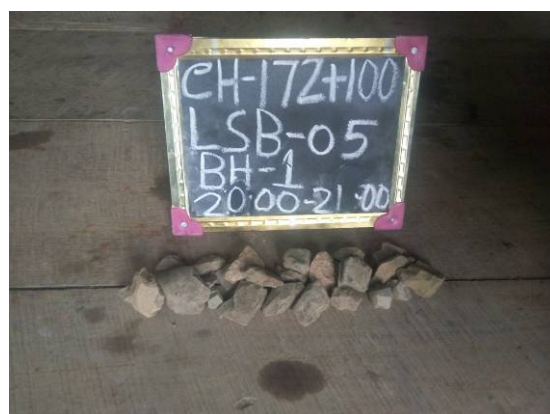
PICTURE 21: BH- 1 (Depth-19.00 to 20.00m)

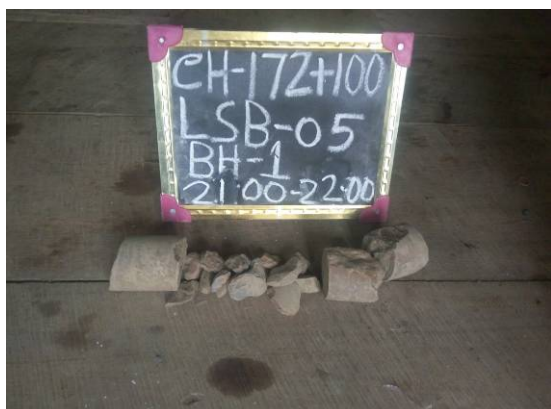
PICTURE 22: BH-1 (Depth-20.00 to 21.00m)

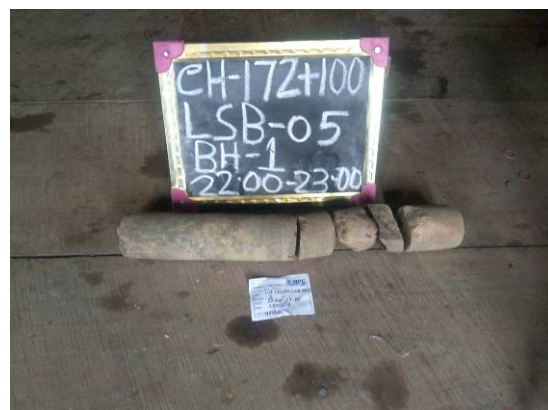
PICTURE 23: BH-1 (Depth-21.00 to 22.00m)

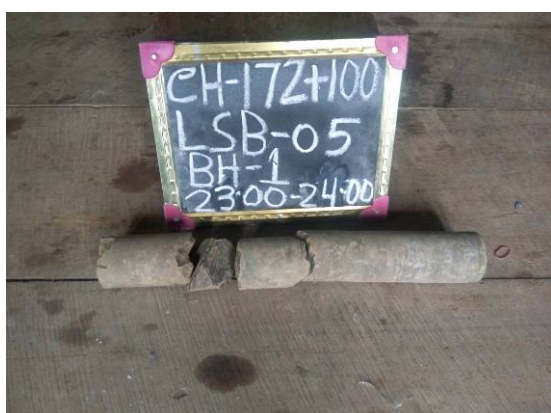
PICTURE 24: BH-1 (Depth-22.00 to 23.00m)

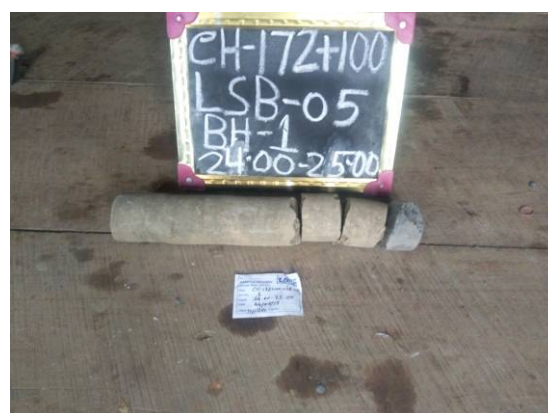
PICTURE 25: BH-1 (Depth-23.00 to 24.00m)

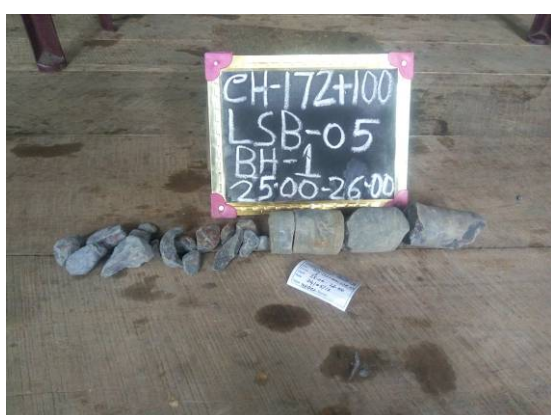
PICTURE 26: BH-1 (Depth-24.00 to 25.00m)

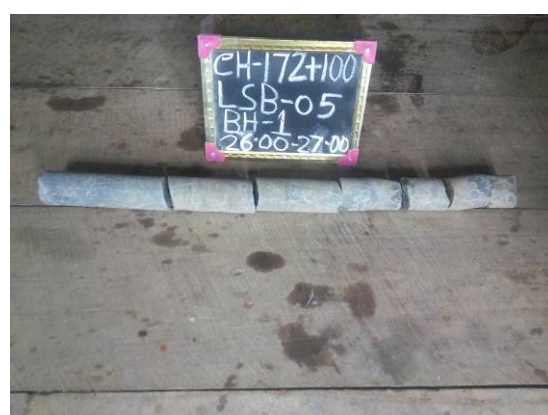
PICTURE 27: BH-1 (Depth-25.00 to 26.00m)

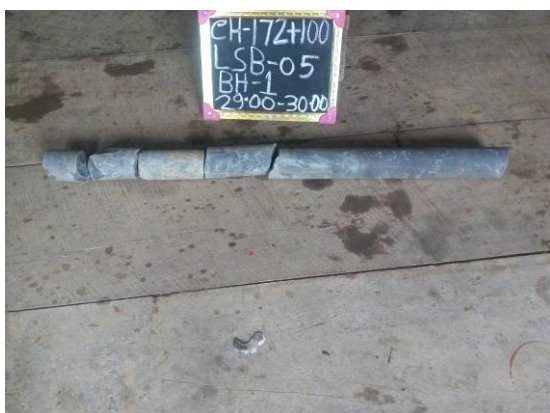
PICTURE 30: BH-1 (Depth-28.00 to 29.00m)

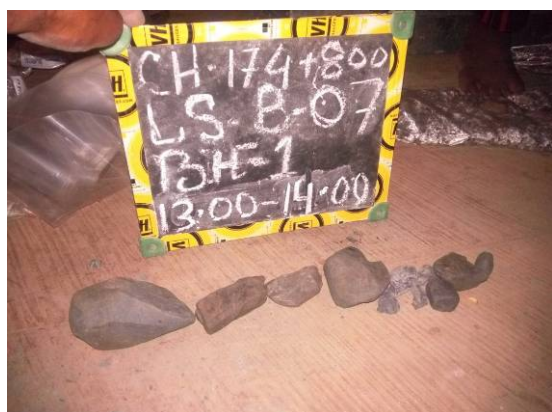
PICTURE 41: BH-1 (Depth-12.00 to 13.00m)

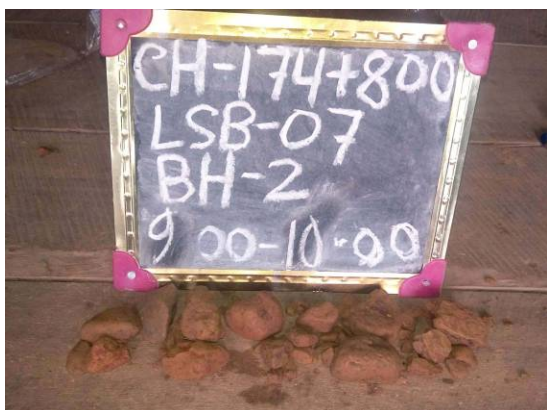
PICTURE 50: BH- 2 (Depth-9.00 to 10.00m)

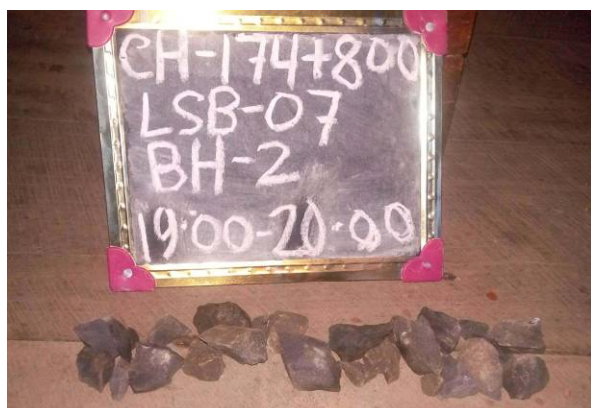
PICTURE 57: BH-2 (Depth-18.00 to 19.00m)

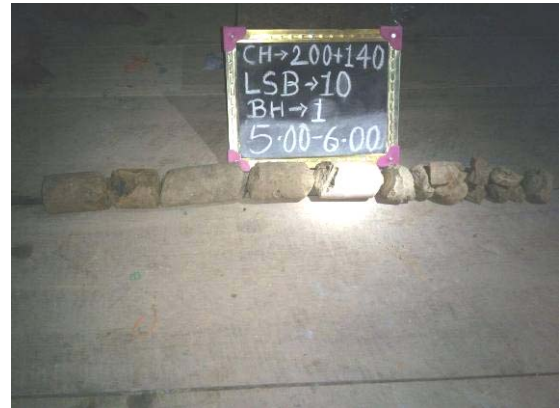
PICTURE 64: BH- 1 (Depth-4.00 to 5.00m)

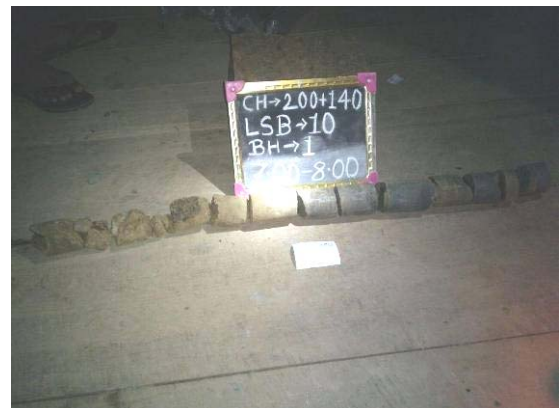
PICTURE 66: BH-1 (Depth-6.00 to 7.00m)

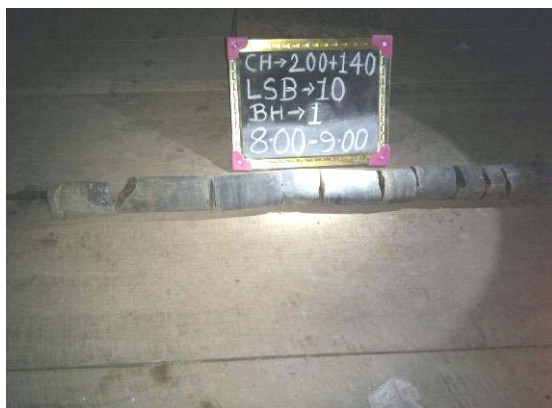
PICTURE 68: BH-1 (Depth-8.00 to 9.00m)

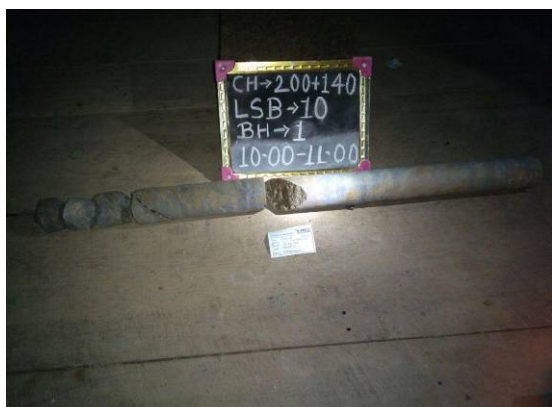
PICTURE 69: BH-1 (Depth-9.00 to 10.00m)

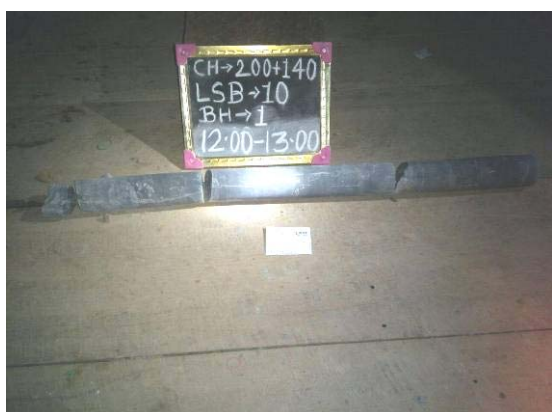
PICTURE 71: BH-1 (Depth-11.00 to 12.00m)

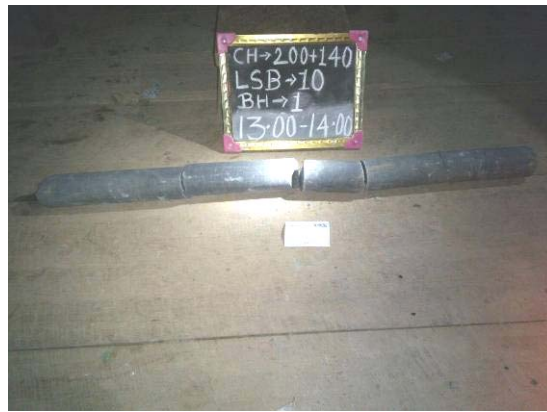
PICTURE 72: BH-1 (Depth-12.00 to 13.00m)

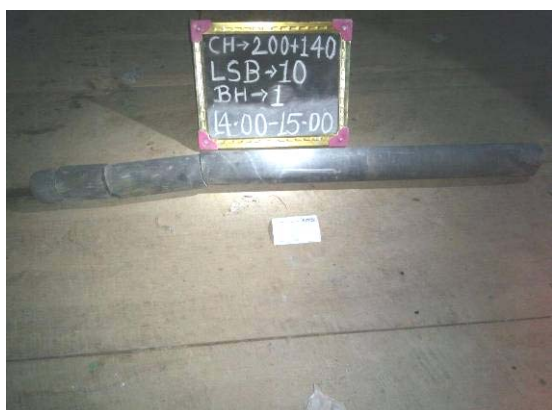
PICTURE 73: BH-1 (Depth-13.00 to 14.00m)

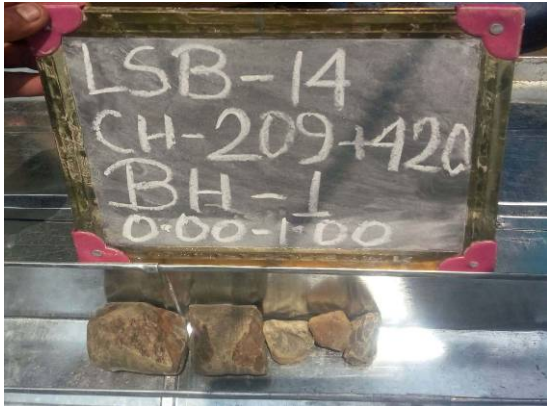
PICTURE 85: BH- 1 (Depth-0.00 to 1.00m)

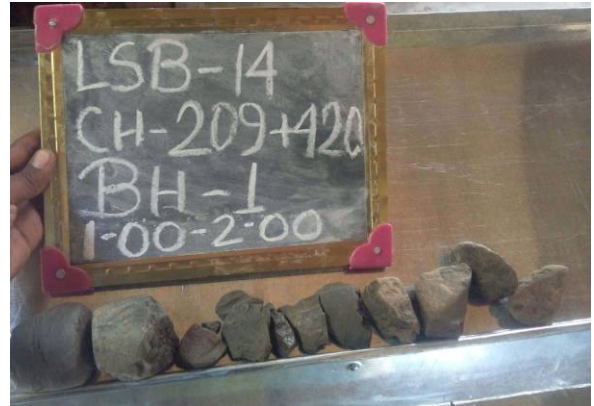
PICTURE 86: BH-1 (Depth-1.00 to 2.00m)

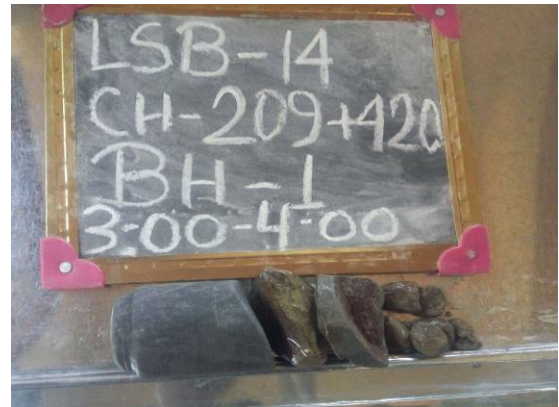
PICTURE 88: BH-1 (Depth-3.00 to 4.00m)

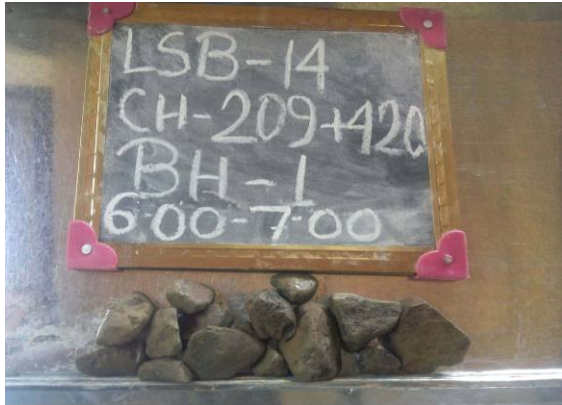
PICTURE 91: BH- 1 (Depth-6.00 to 7.00m)

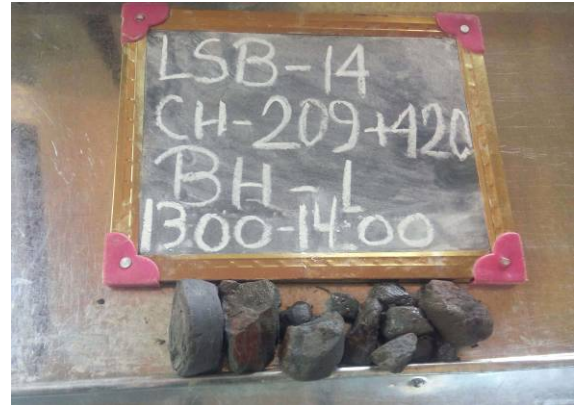
PICTURE 98: BH-1 (Depth-13.00 to 14.00m)

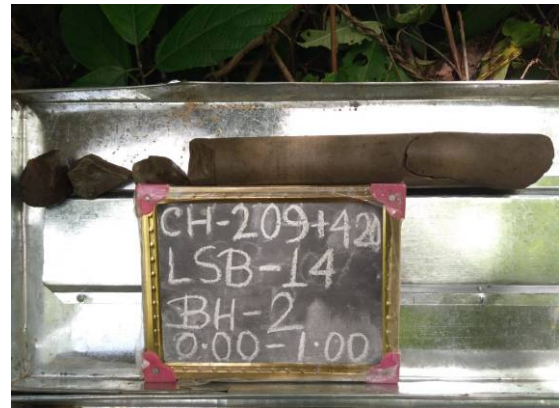
PICTURE 100: BH-2 (Depth-0.00 to 1.00m)

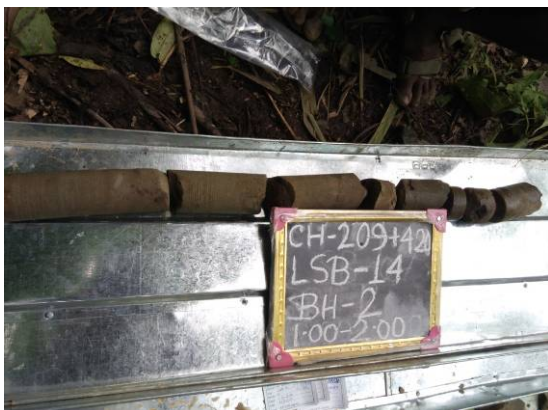
PICTURE 101: BH-2 (Depth-1.00 to 2.00m)

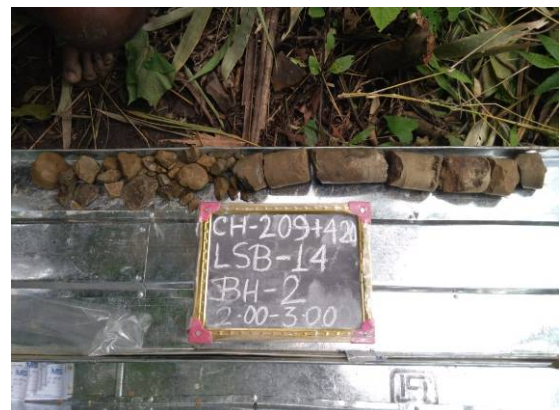
PICTURE 102: BH-2 (Depth-2.00 to 3.00m)

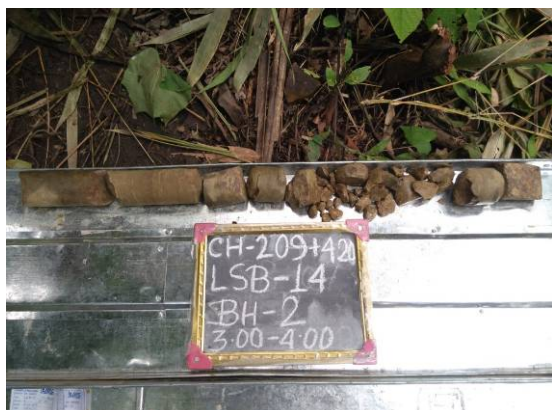
PICTURE 103: BH- 2 (Depth-3.00 to 4.00m)

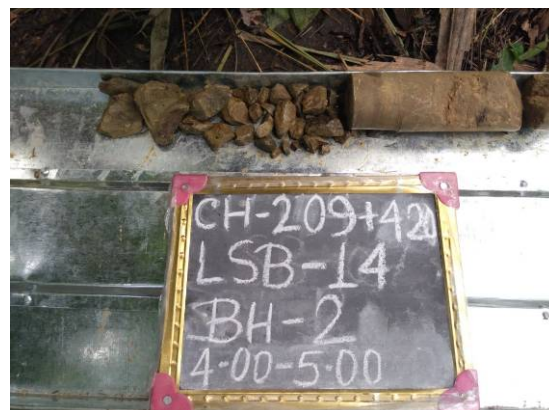
PICTURE 104: BH-2 (Depth-4.00 to 5.00m)

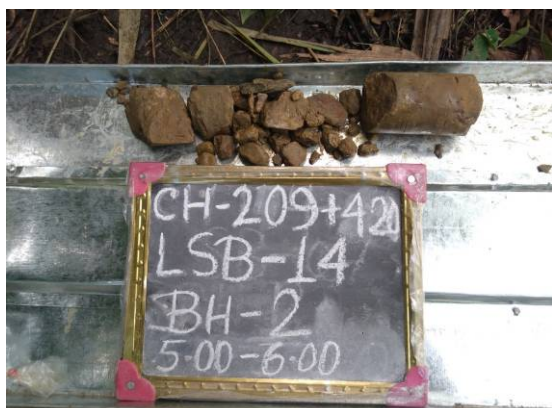
PICTURE 105: BH-2 (Depth-5.00 to 6.00m)

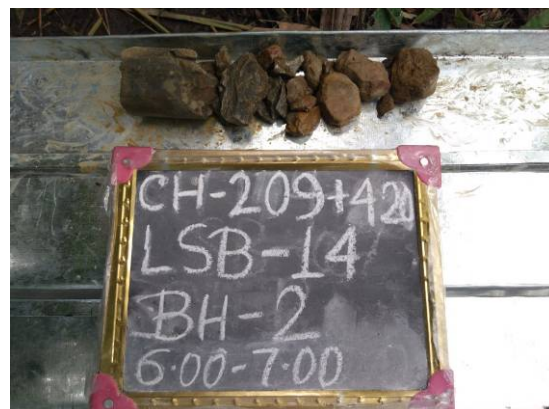
PICTURE 106: BH-2 (Depth-6.00 to 7.00m)

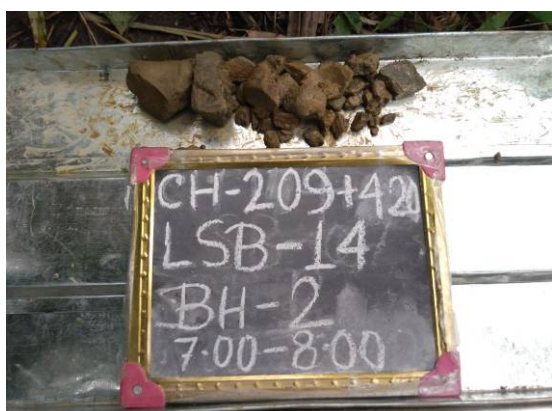
PICTURE 107: BH-2 (Depth-7.00 to 8.00m)

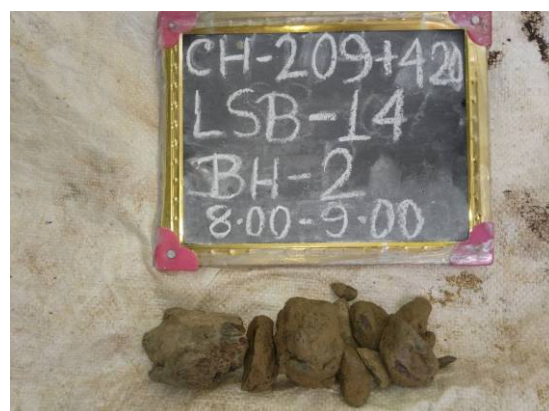
PICTURE 108: BH-2 (Depth-8.00 to 9.00m)

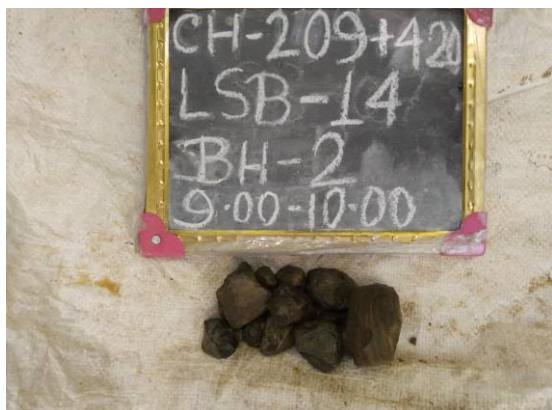
PICTURE 109: BH- 2 (Depth-9.00 to 10.00m)

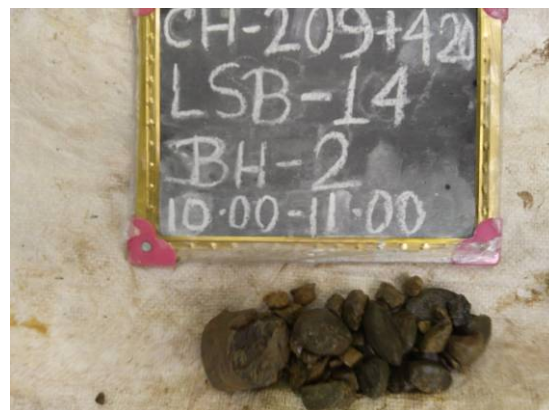
PICTURE 110: BH-2 (Depth-10.00 to 11.00m)

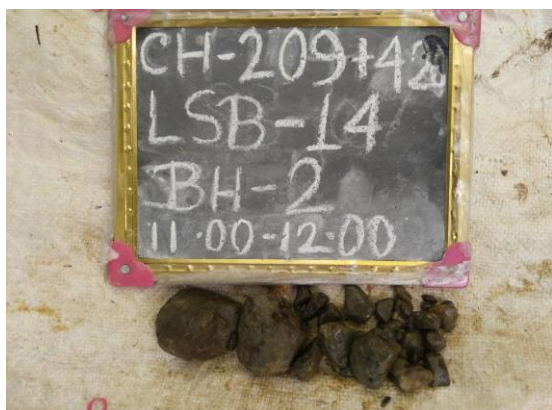
PICTURE 111: BH-2 (Depth-11.00 to 12.00m)

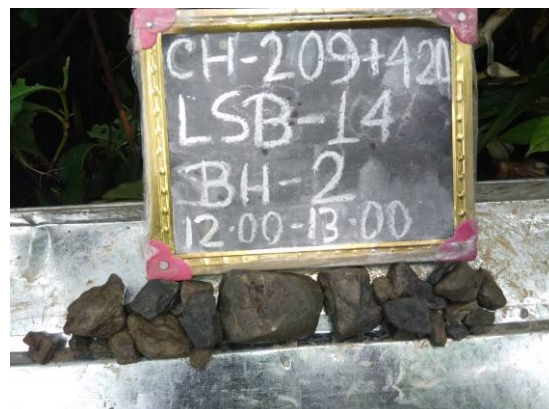
PICTURE 112: BH-2 (Depth-12.00 to 13.00m)

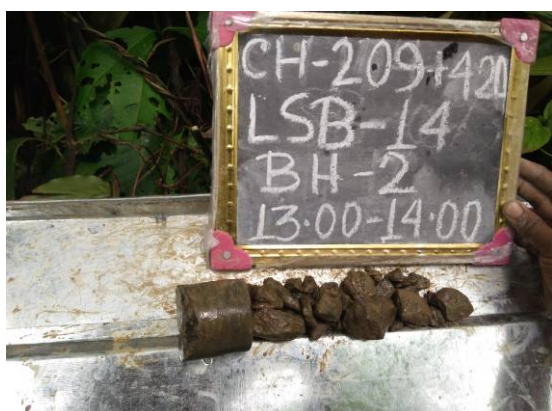
PICTURE 113: BH-2 (Depth-13.00 to 14.00m)

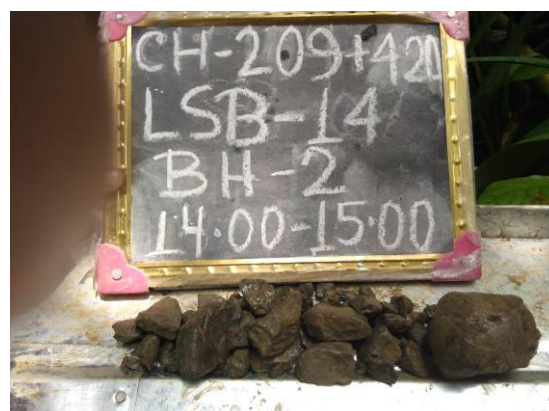
PICTURE 114: BH-2 (Depth-14.00 to 15.00m)

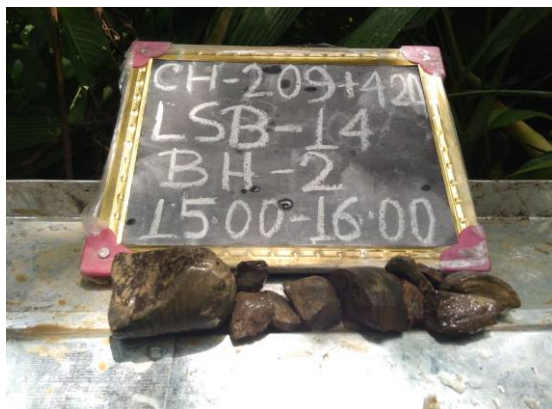
PICTURE 115: BH- 2 (Depth-15.00 to 16.00m)

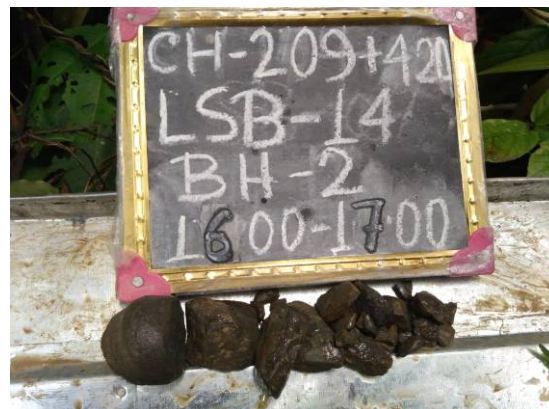
PICTURE 116: BH-2 (Depth-16.00 to 17.00m)

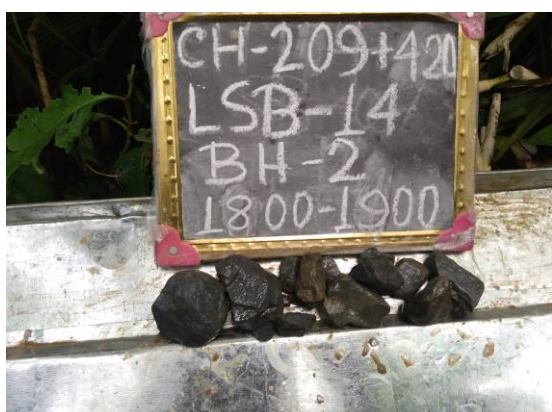
PICTURE 117: BH-2 (Depth-18.00 to 19.00m)

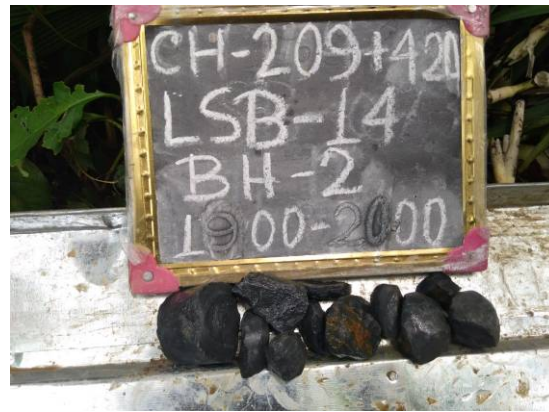
PICTURE 118: BH-2 (Depth-19.00 to 20.00m)

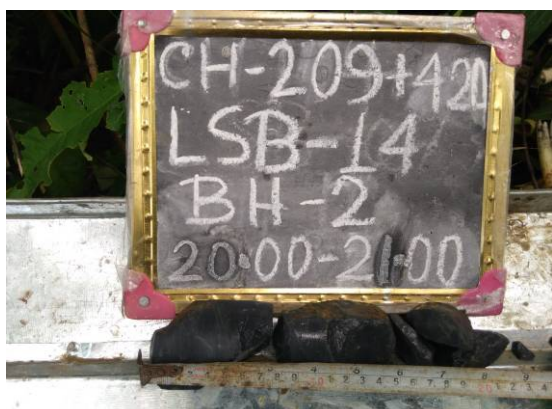
PICTURE 119: BH-2 (Depth-20.00 to 21.00m)

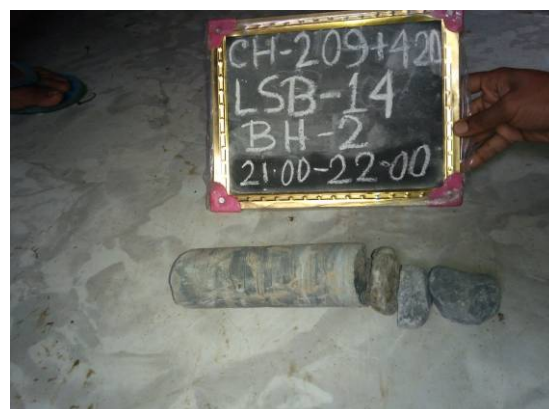
PICTURE 120: BH-2 (Depth-21.00 to 22.00m)

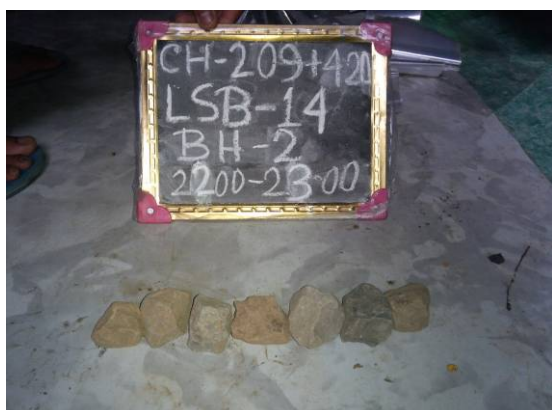
PICTURE 121: BH- 2 (Depth-22.00 to 23.00m)

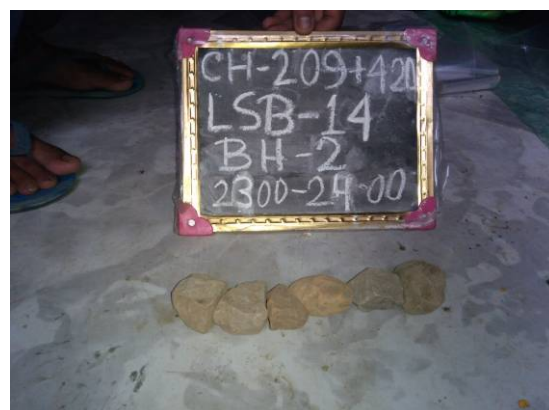
PICTURE 122: BH-2 (Depth-23.00 to 24.00m)

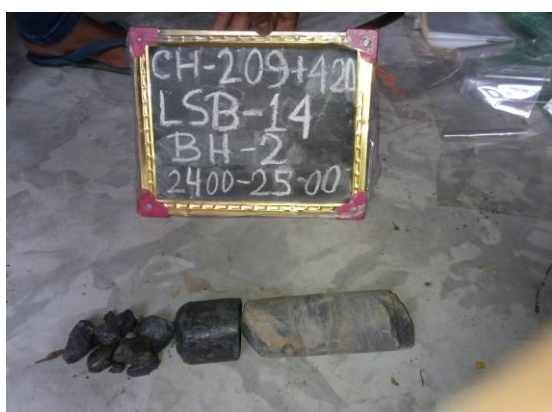
PICTURE 123: BH-2 (Depth-24.00 to 25.00m)
