# **Bore Log and Core Sample Photographs LS-A28**

| Project Name : | | Consultancy Services for additional Topographical, Geotechnical Survey for widening and upgradation of NH-54 from km 8.00 to km 380.00 in the State of Mizoram. | | | | BPC Consultant INDIA (P) Ltd. | | | | | | | | | | | | | | |
| BORE / CORE LOG DATA SHEET | | | | | | | | | | | | | | | | | | | | |

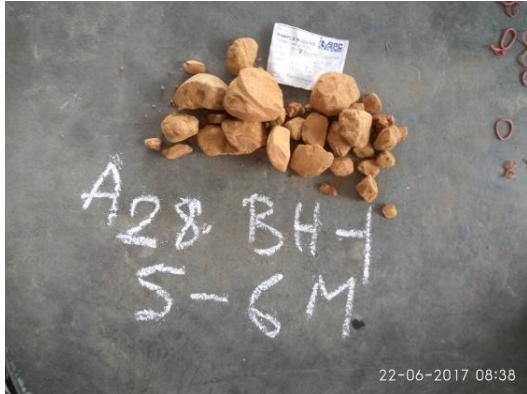
PICTURE 292: BH-1 (Depth-5.00 to 6.00m)

| Highly Weathered, Brownish / Reddish, Fine grained Sandstone. 5.00 m to 9.00 m | | 1017.1630 | 1013.1630 | | 1017.1630 | | - | S | 12cm / 56B | Re | Re | >100 | 70 | - | - | - | Brownish | - | - | |

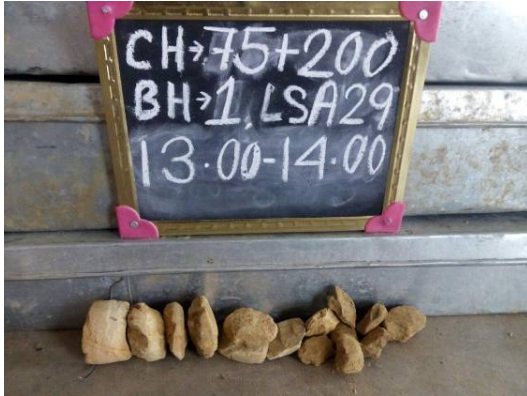
PICTURE 297: BH-1 (Depth-13.00 to 14.00m)

| Highly Weathered, Brownish / Yellowish Grey, Fine grained highly fracture Poor Sandstone. 13.00 m to 20.00 m | 1054.7430 | | | 1054.7430 | | - | S | 42 | 10cm / 71B | Re | >100 | 54 | - | - | - | - | - | - | |

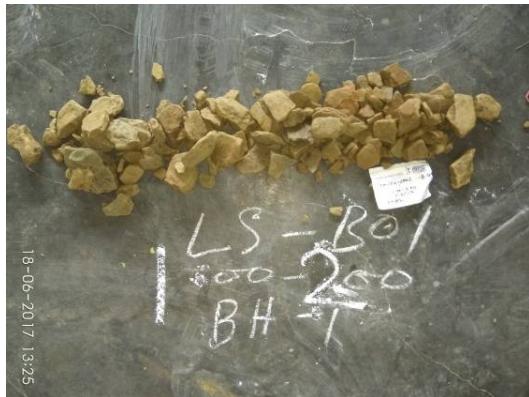
PICTURE 325: BH-1 (Depth-1.00 to 2.00m)

| Highly Weathered, Grey, Highly fracture Soft Shale.<br>1.00 m to 3.00 m | 897.2688 | | | 897.2688 | | - | S | 3cm / 48B | Re | Re | >100 | 97 | - | - | - | - | - | - |

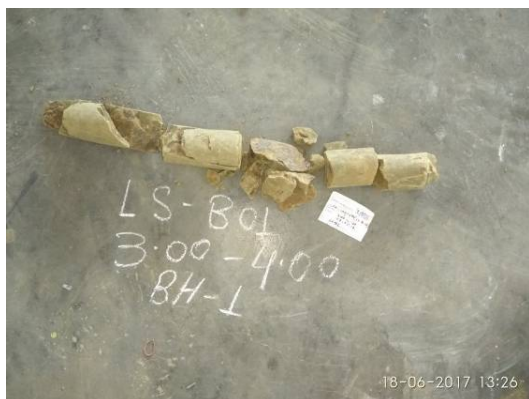
PICTURE 327: BH-1 (Depth-3.00 to 4.00m)

| Moderately Weathered, Dark greyish, Fine grained moderately fracture Strong Sandy Shale.<br>3.00 m to 10.00 m | 895.2688 | | | 895.2688 | | 1.00 | R4 | - | - | - | - | - | 72 | 72 | NIL | | | 80°-90° |

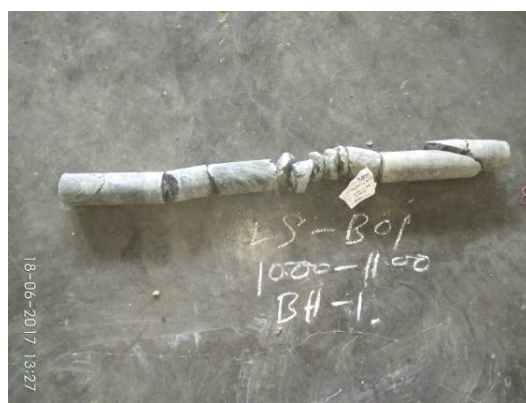
PICTURE 334: BH-1 (Depth-10.00 to 11.00m)

| Dark greyish / Greyish, Fine grained slightly fracture Strong Shale with laminated Sandstone observed of some layer.<br>10.00 m to 20.00 m | 886.2688 | | | 885.2688 | | 1.00 | R14 | - | - | - | - | - | 63 | 63 | 35 | | | 45° |
